City of Phoenix

ANNUAL REPORT

PHX WATER SMART

Re: ANNUAL REPORT FOR AZPDES PERMIT NO. AZS000003,
MUNICIPAL SEPARATE STORM SEWER SYSTEM

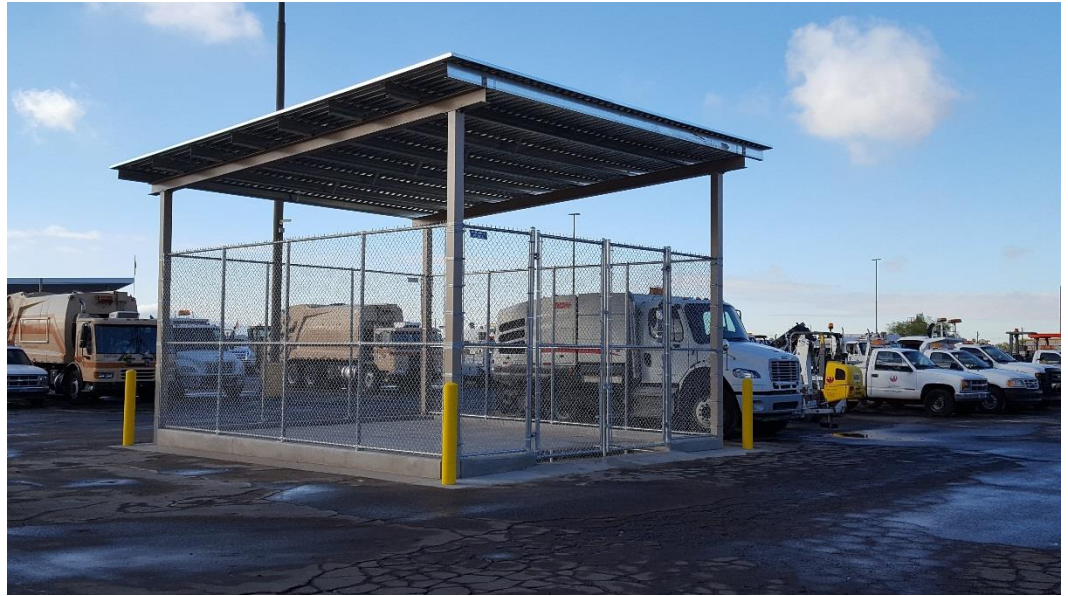
- Glenrosa Covered Storage – Following the fourth quarter of 2016 annual OEP SWPPP inspection, it was noted that the Glenrosa Service Center, PWD Fleet Services Division was in need of additional covered storage. Funding for design and construction was encumbered in the second quarter of 2017. Additional internal soft costs occurred in reporting year 2017/18. The covered storage was completed in January 2018. The covered storage is used by site staff to store greasy/oily vehicle parts and other potentially leaking material in a location that is not exposed to stormwater.

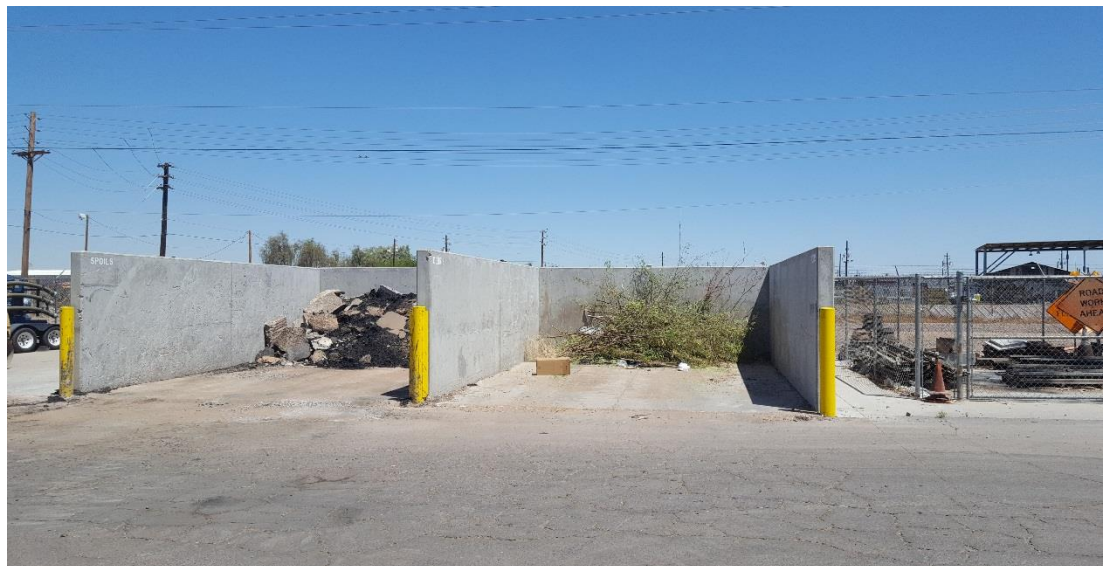
- Okemah Bulk Material Storage Bins – Following the fourth quarter 2015 and 2016 annual OEP SWPPP inspections, it was noted that the Okemah Service Center, STR Department was in need of modifications to the bulk material storage bins, and additional bins. Funding was encumbered in the second quarter of 2017 to build two new bulk material storage bins to contain concrete debris and spoils. Additional internal soft costs occurred in reporting year 2017/18. The bins were completed in January 2018. Use of the new bins also allows one of the existing bins to be used for excess storage.

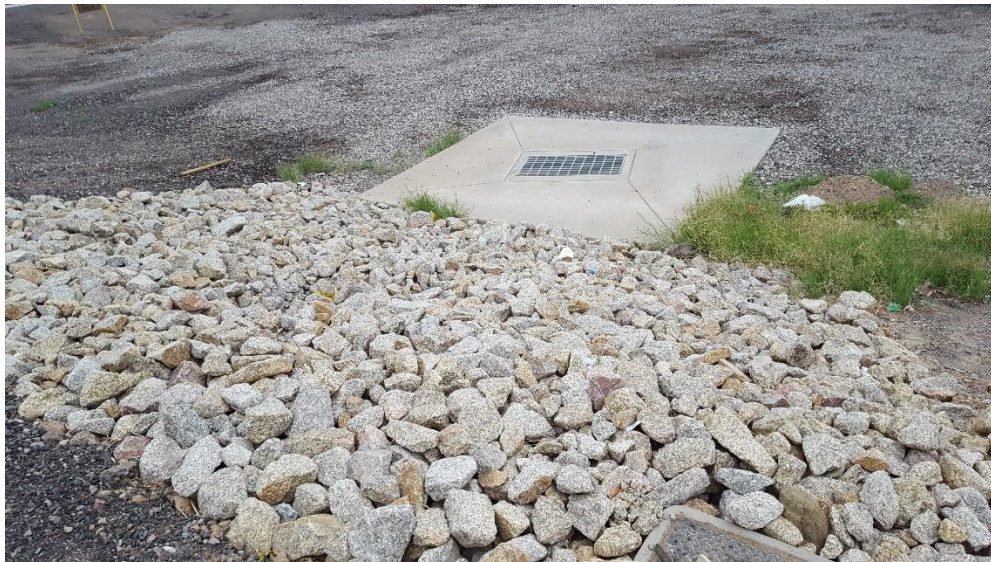
- Baseline Road, 51st Avenue to 59th Avenue – This project, which widened Baseline Road from two lanes to four lanes with center raised median, included installation of several new catch basins and expanding/modifying existing catch basins to improve stormwater drainage.

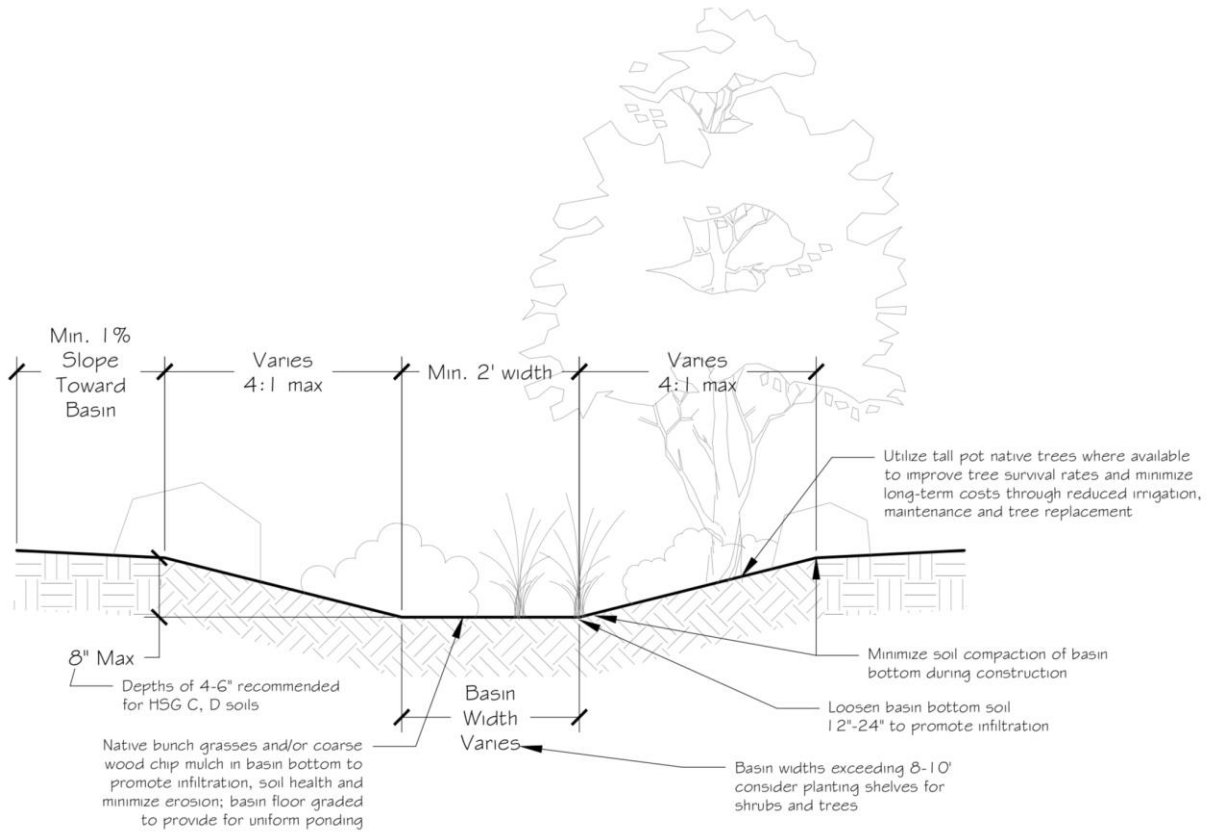
Figure 4: Typical Bioretention Basin Cross-section
 Source: Watershed Management Group

- Capital costs for Bioretention Basins are based on WMG's experience over the last decade in Tucson as well as the last 5 years in Phoenix designing and constructing basins. Costs include labor, design, curb cuts, shrubs, grasses, trees, rock and/or wood mulch, permitting, excavation and soil hauling. Costs vary depending on existing site conditions such as topography, land use, hardscape and soil type as well as if a curb cut is needed.
- O&M costs are from Watershed Management Group estimates based on \$120/1,000 sq ft at a rate of \$75/hr.

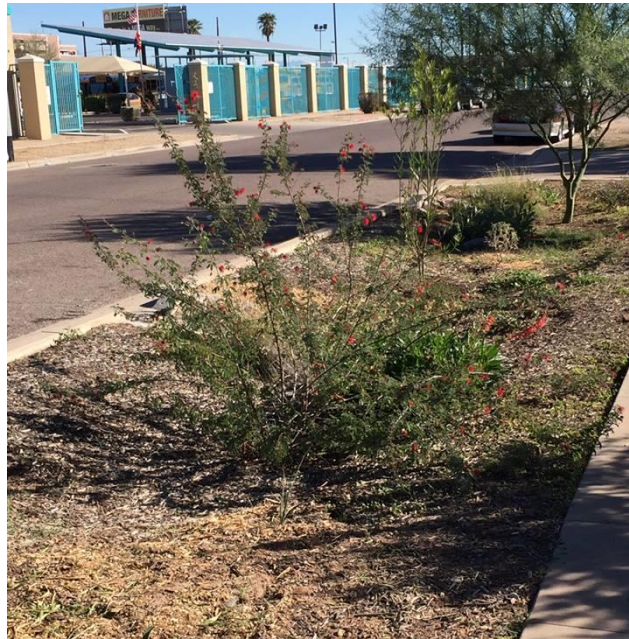
Figure 5: Bioretention Basin
 Source: City of Phoenix, Office of Environmental Programs.

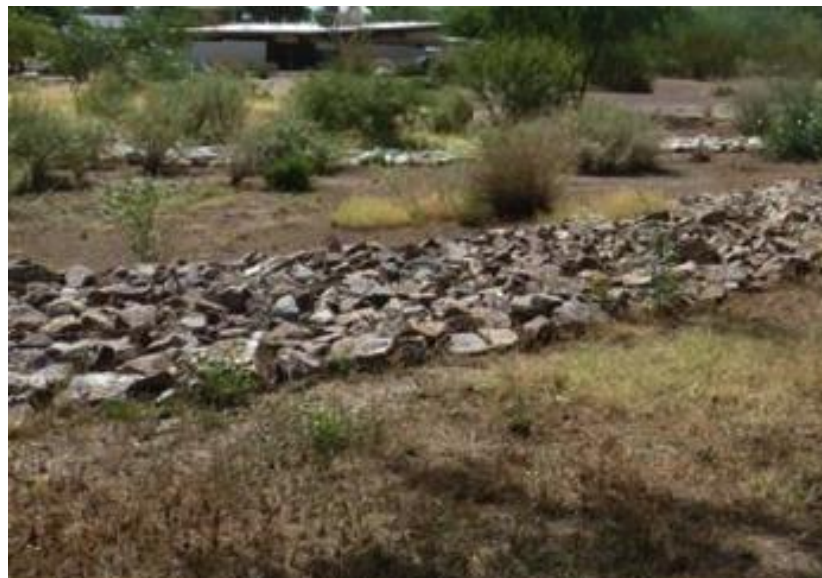
Figure 6: Infiltration Trench

- CapEx is from EPA’s SUSTAIN database and includes: backfilling, excavation, filter fabric, grading/finishing, grass, gravel, mulch, observation well, perennials, soil/planting media.
- O&M costs are from Watershed Management Group estimates based on \$120/1,000 sq ft at a rate of \$75/hr.

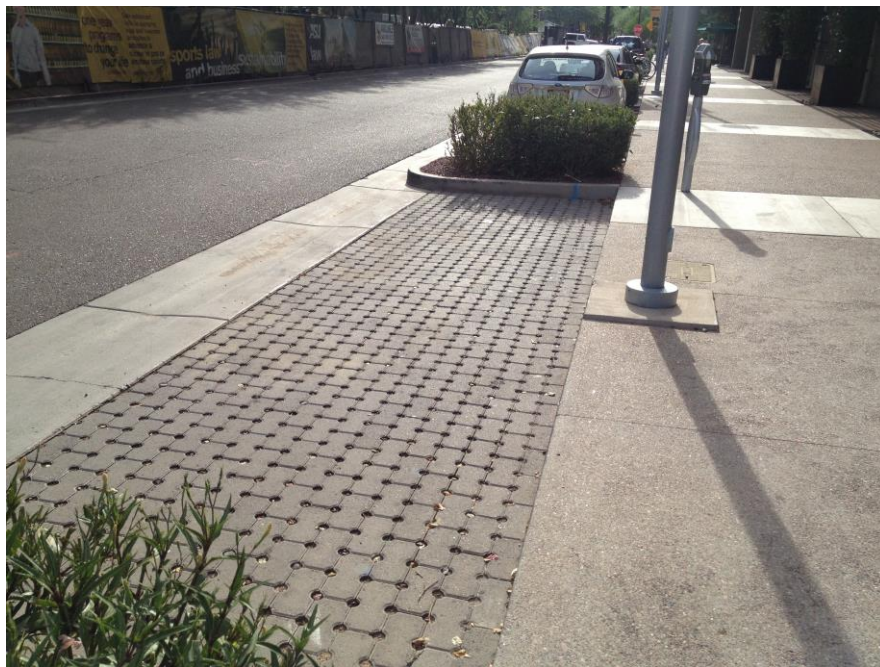
Figure 7: Pervious Pavers (Interlocking Porous Concrete Pavers)
Source: City of Phoenix, Office of Environmental Programs.

- CapEx: Expected = using Taylor Mall 100 Plan Cost Model. Low and High from SUSTAIN.
- O&M costs calculated from Glendale Park and Ride at 99th Ave, which is porous concrete. O&M cost for power washing for FY 2017 was \$2,580 across an area of 214,053 sq ft. Low = 1 wash per year, Expected = 2 times per year, High = 4 times per year.

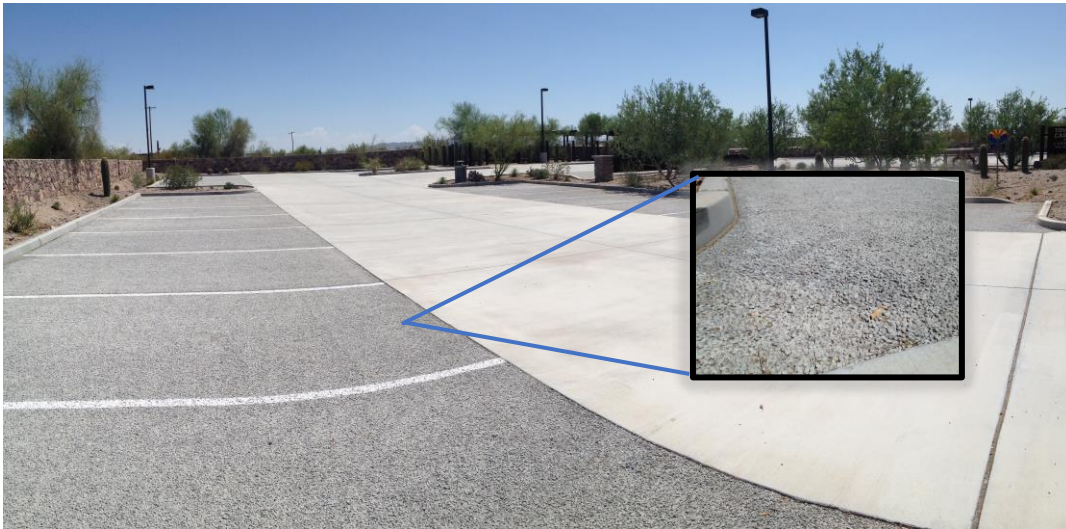
Figure 9: Example Porous Concrete Installation
 Source: City of Phoenix, Office of Environmental Programs

- CapEx: Expected = Site specific cost from the line items taken from Central Station Upgrades. Low and High values taken from SUSTAIN.
- O&M costs calculated from Glendale Park and Ride at 99th Ave, which is porous concrete. O&M cost for power washing for FY 2017 was \$2,580 across an area of 214,053 sq ft. Low = 1 wash per year, Expected = 2 times per year, High = 4 times per year

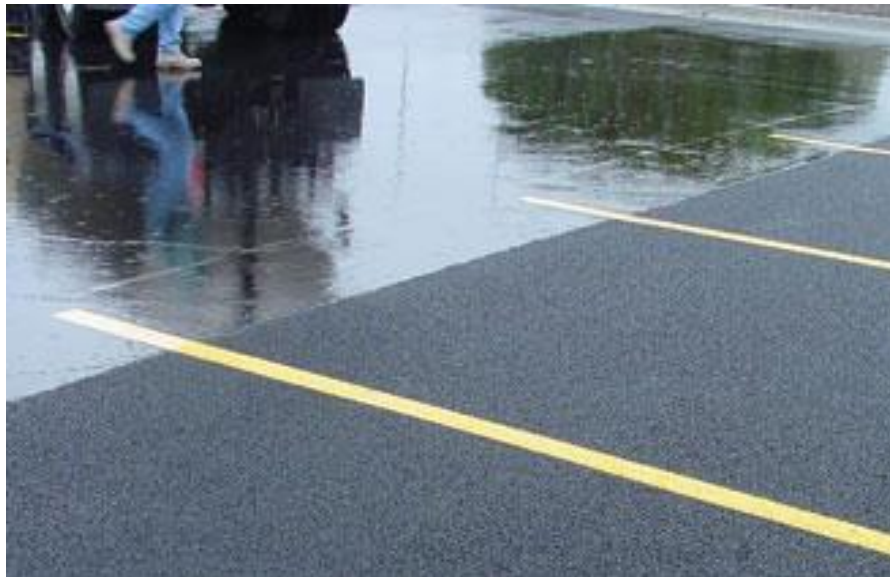
Figure 11: Porous Asphalt

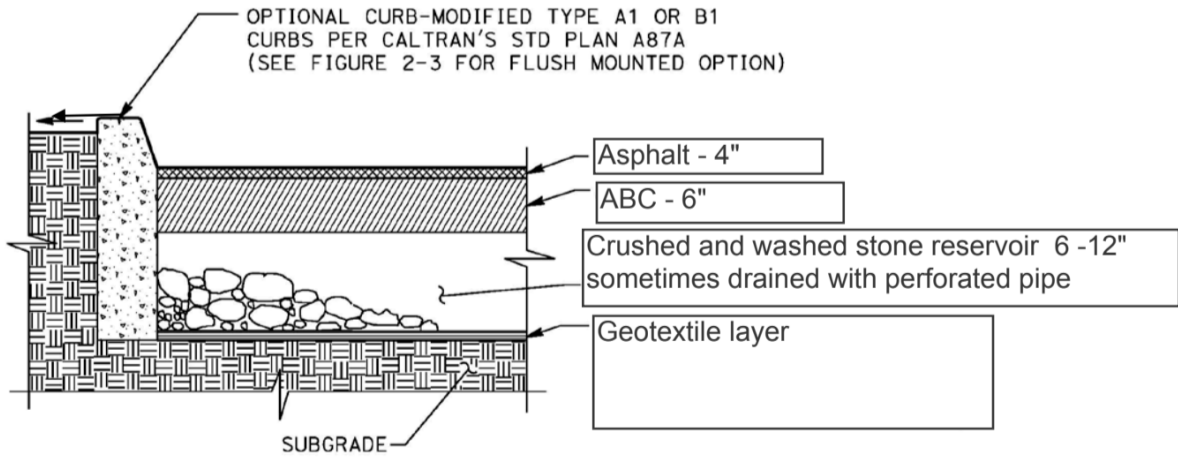
Figure 12: Design Detail for Typical Asphalt
Source: Stantec

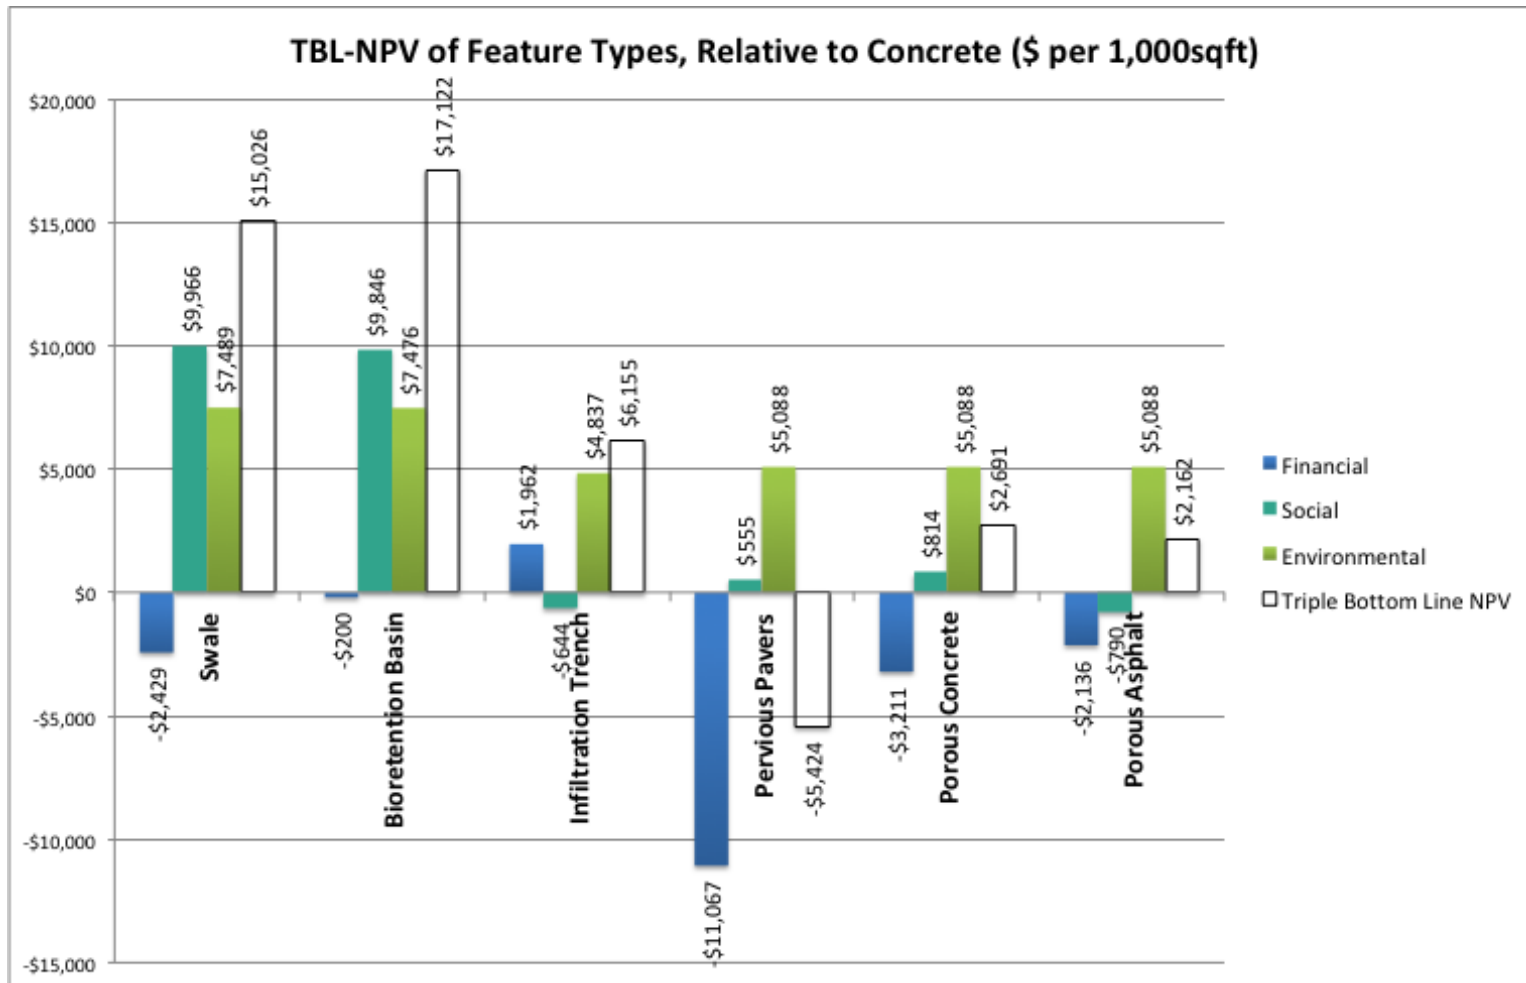
Figure 14: TBL-NPV Results of Feature Types Relative to Concrete (\$ per 1,000 sq ft)

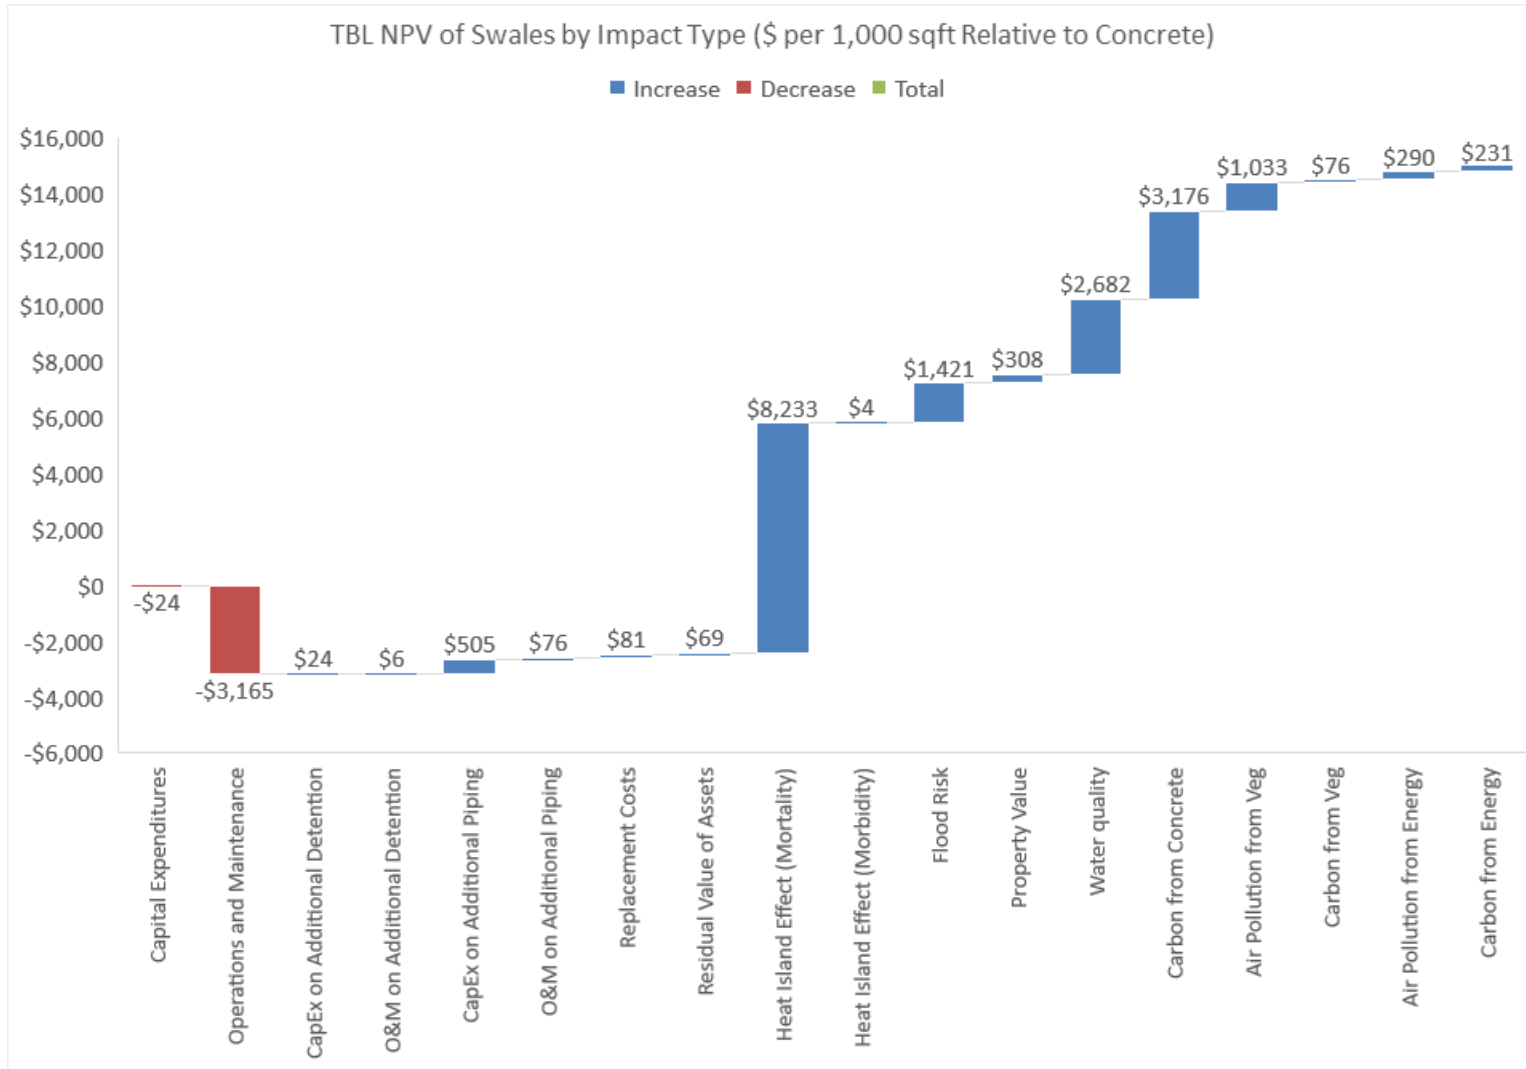
Financial	Social	Environmental
-\$2,429	\$9,966	\$7,489
Triple Bottom Line NPV		\$15,026

Figure 15: Breakdown of TBL NPV for Swales

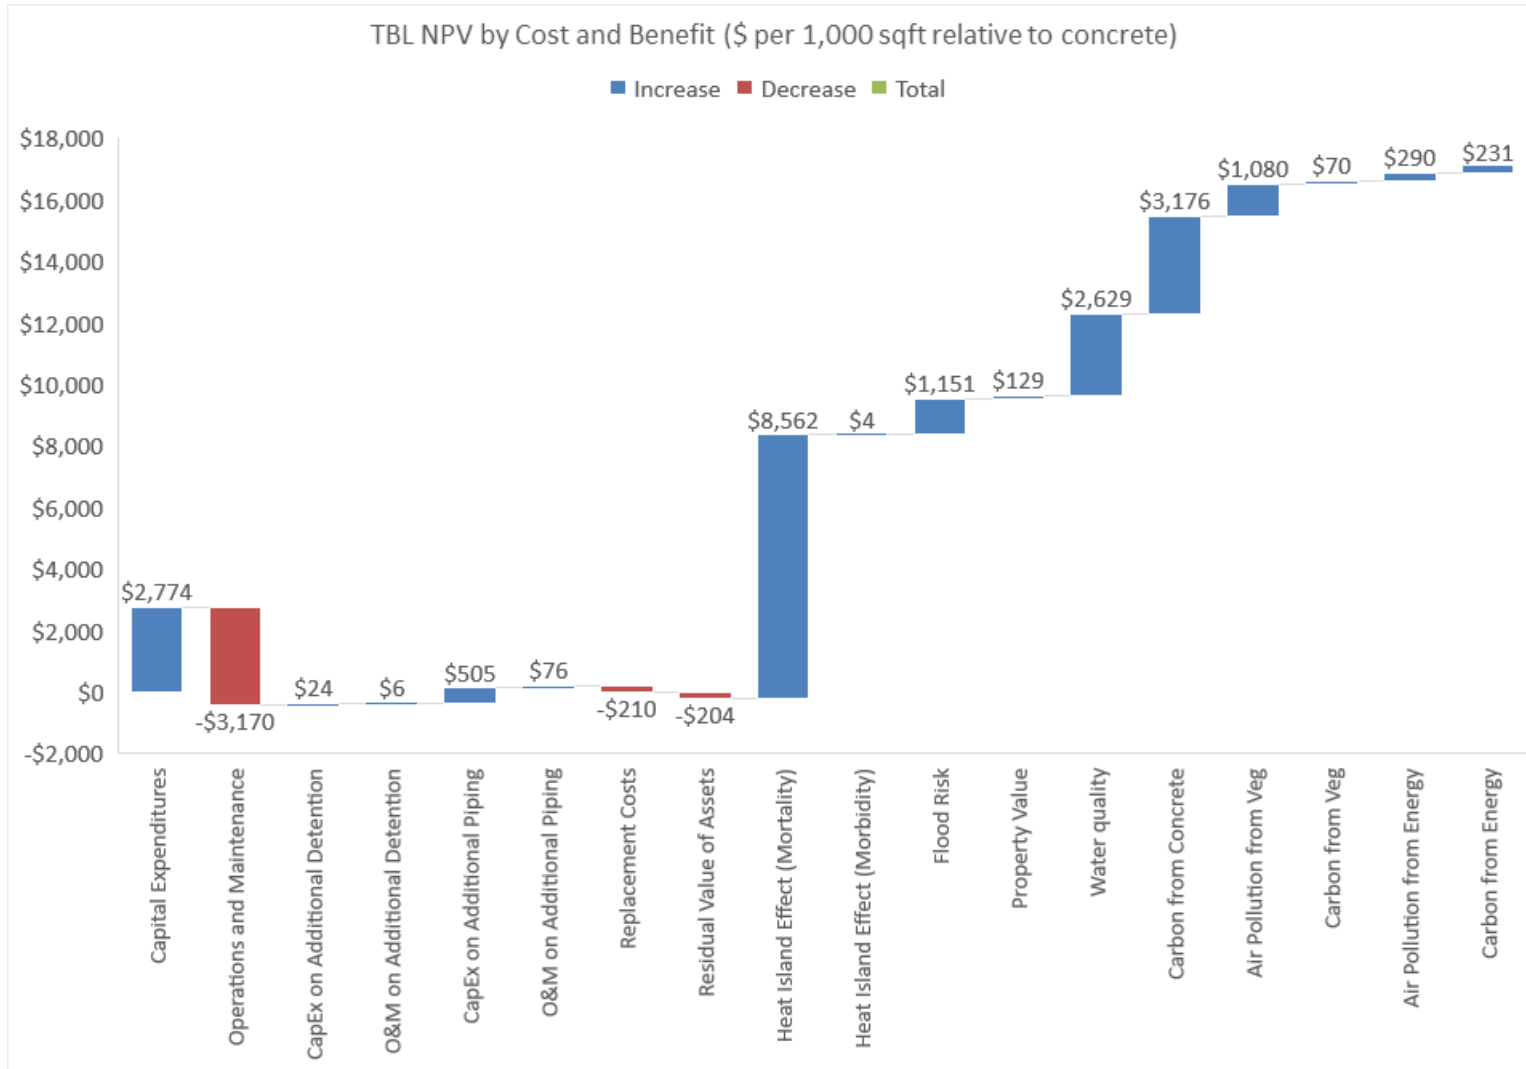
Figure 16: Breakdown of TBL NPV for Bioretention Basins

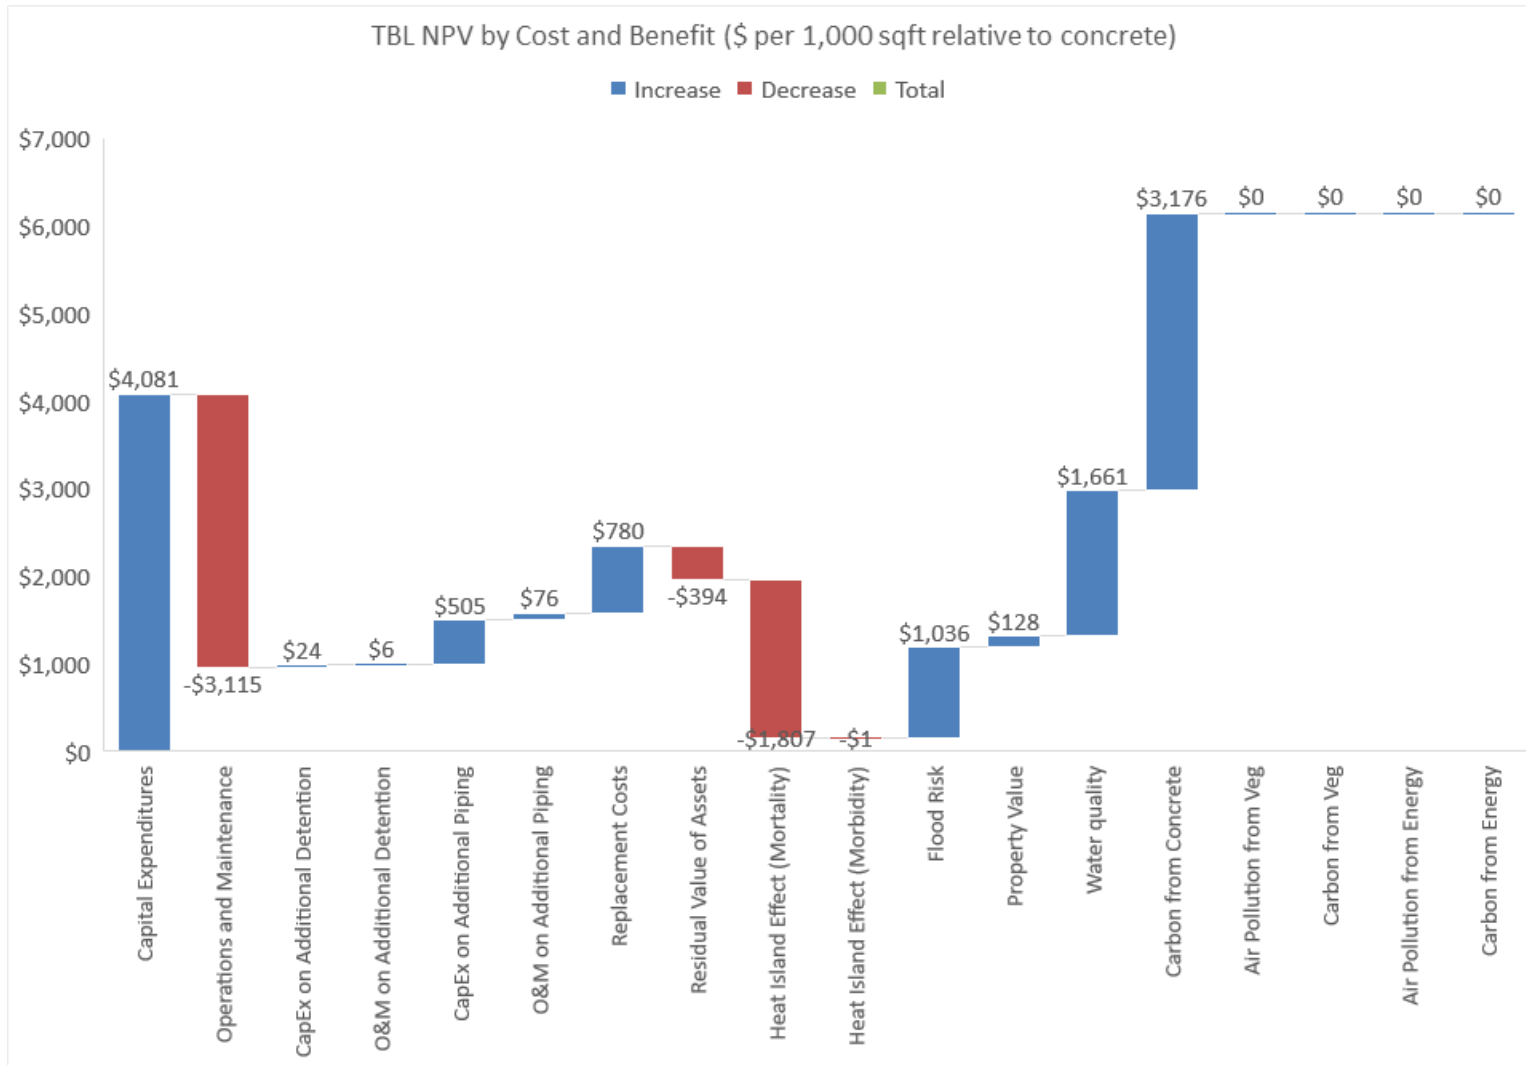
Figure 17: Breakdown of TBL NPV for Infiltration Trenches

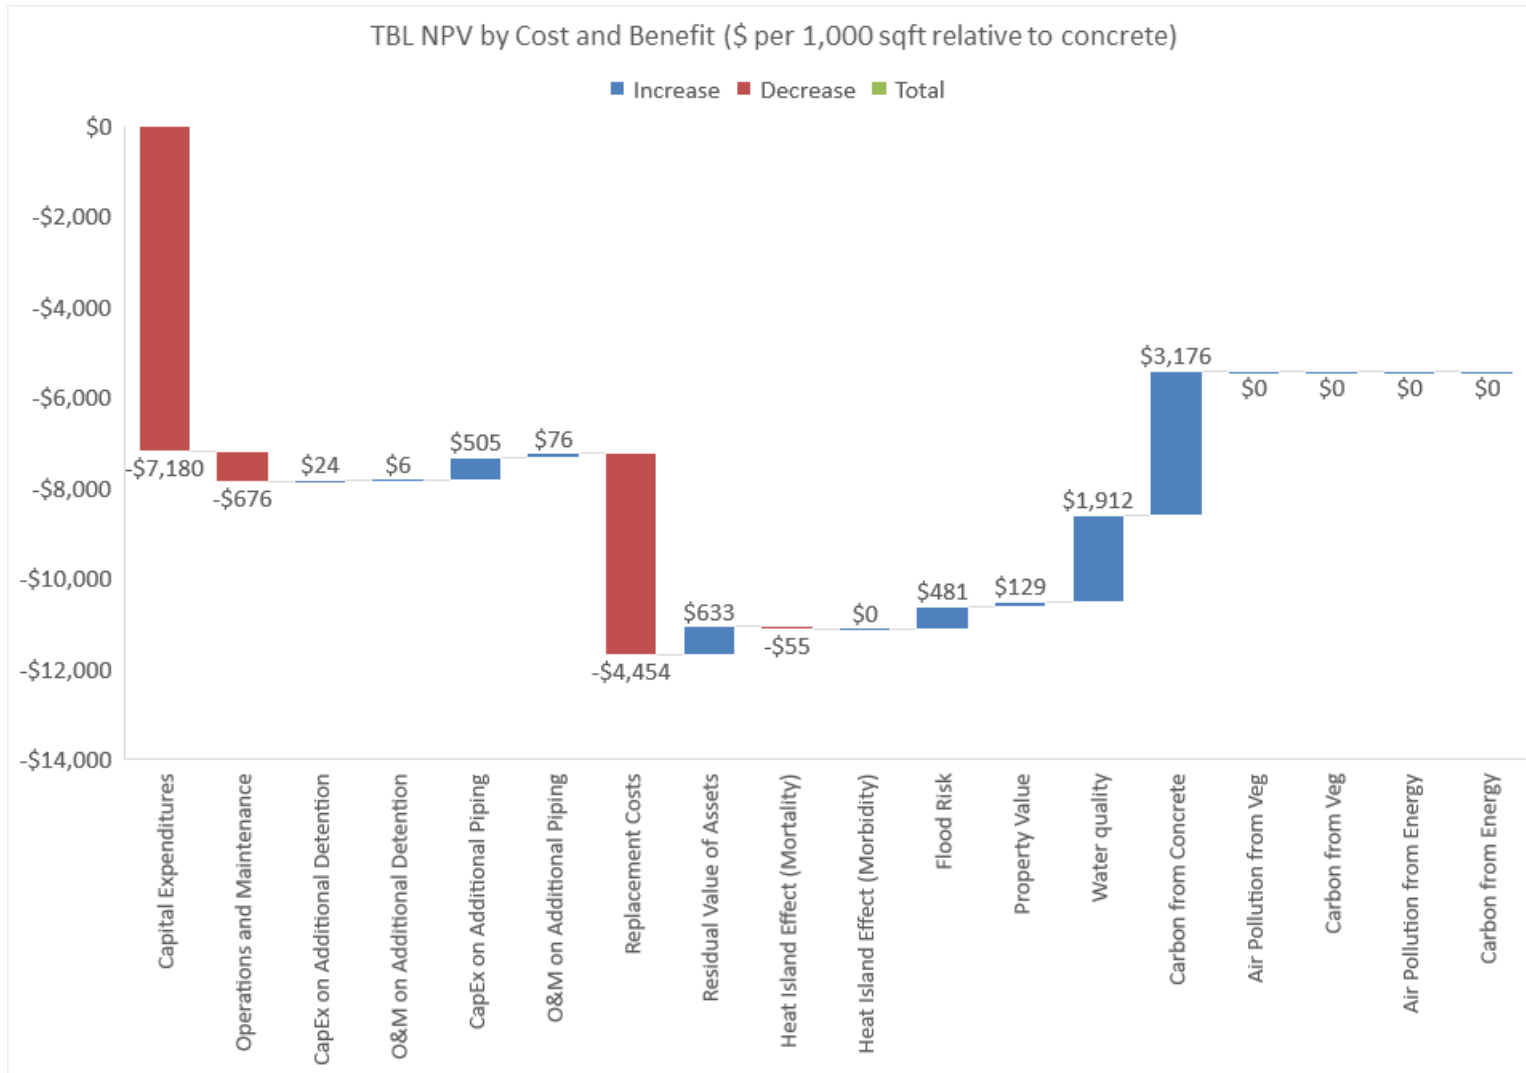
Figure 18: Breakdown of TBL NPV for Pervious Pavers

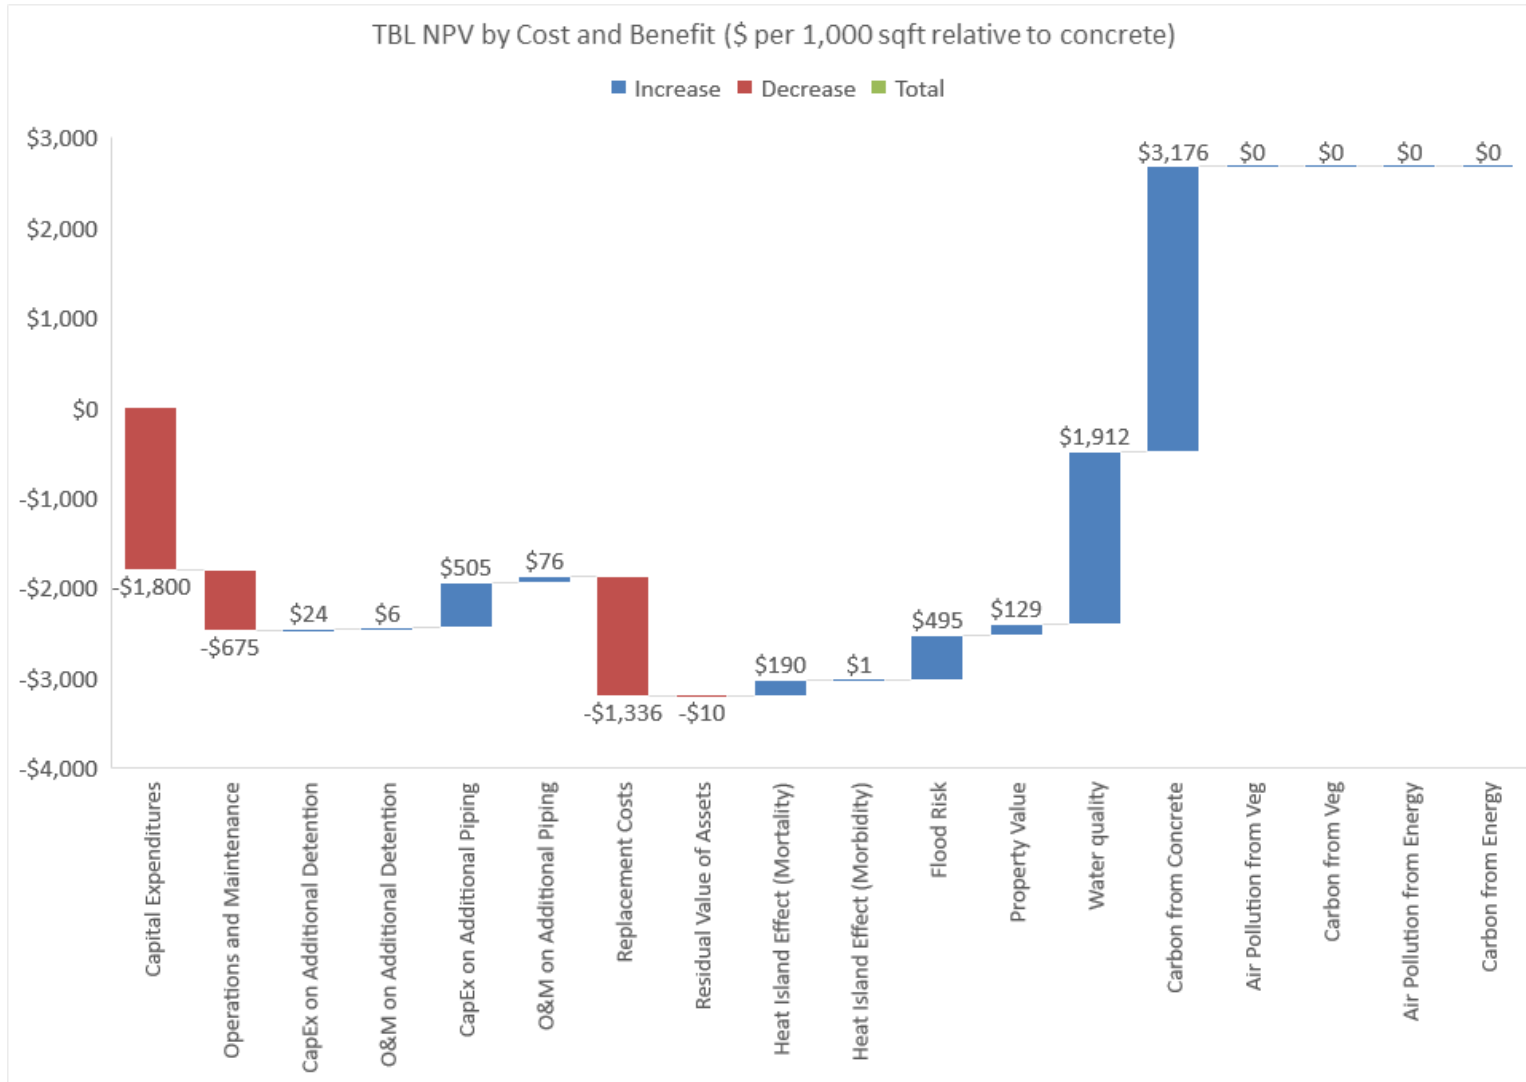
Figure 19: Breakdown of TBL NPV for Porous Concrete

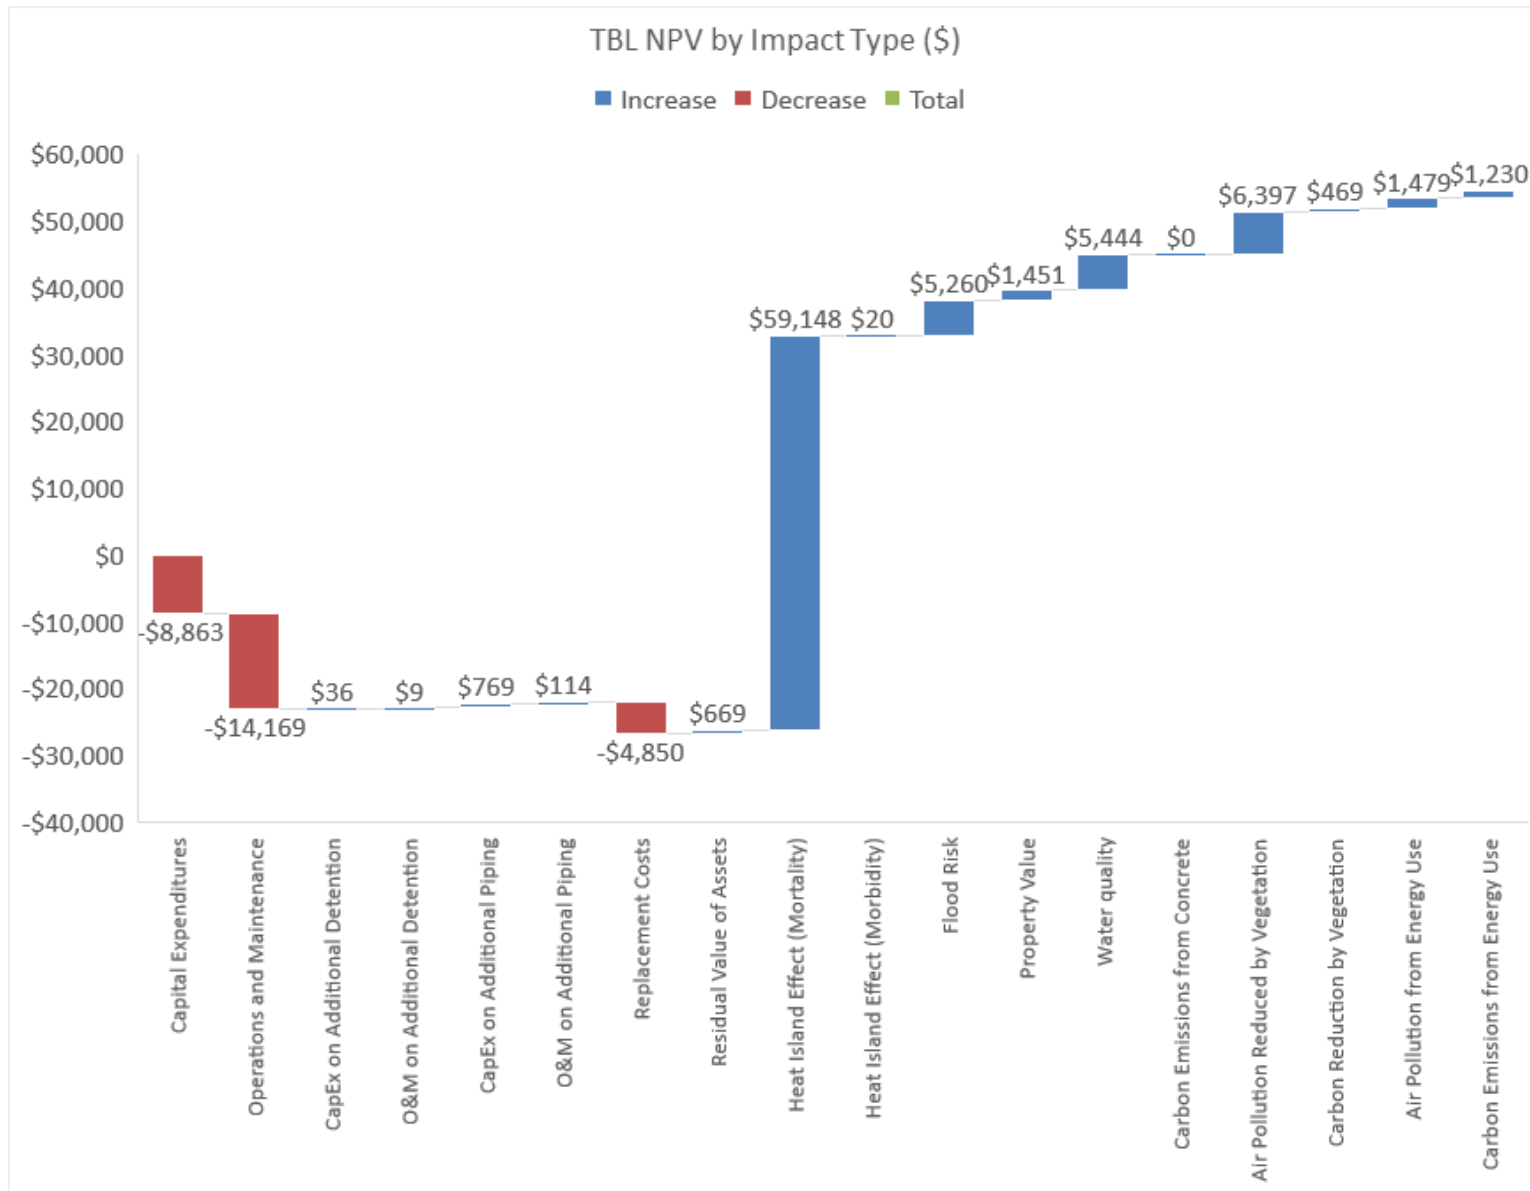
Figure 31: Breakdown of TBL NPV by Impact Type for Primera Iglesia

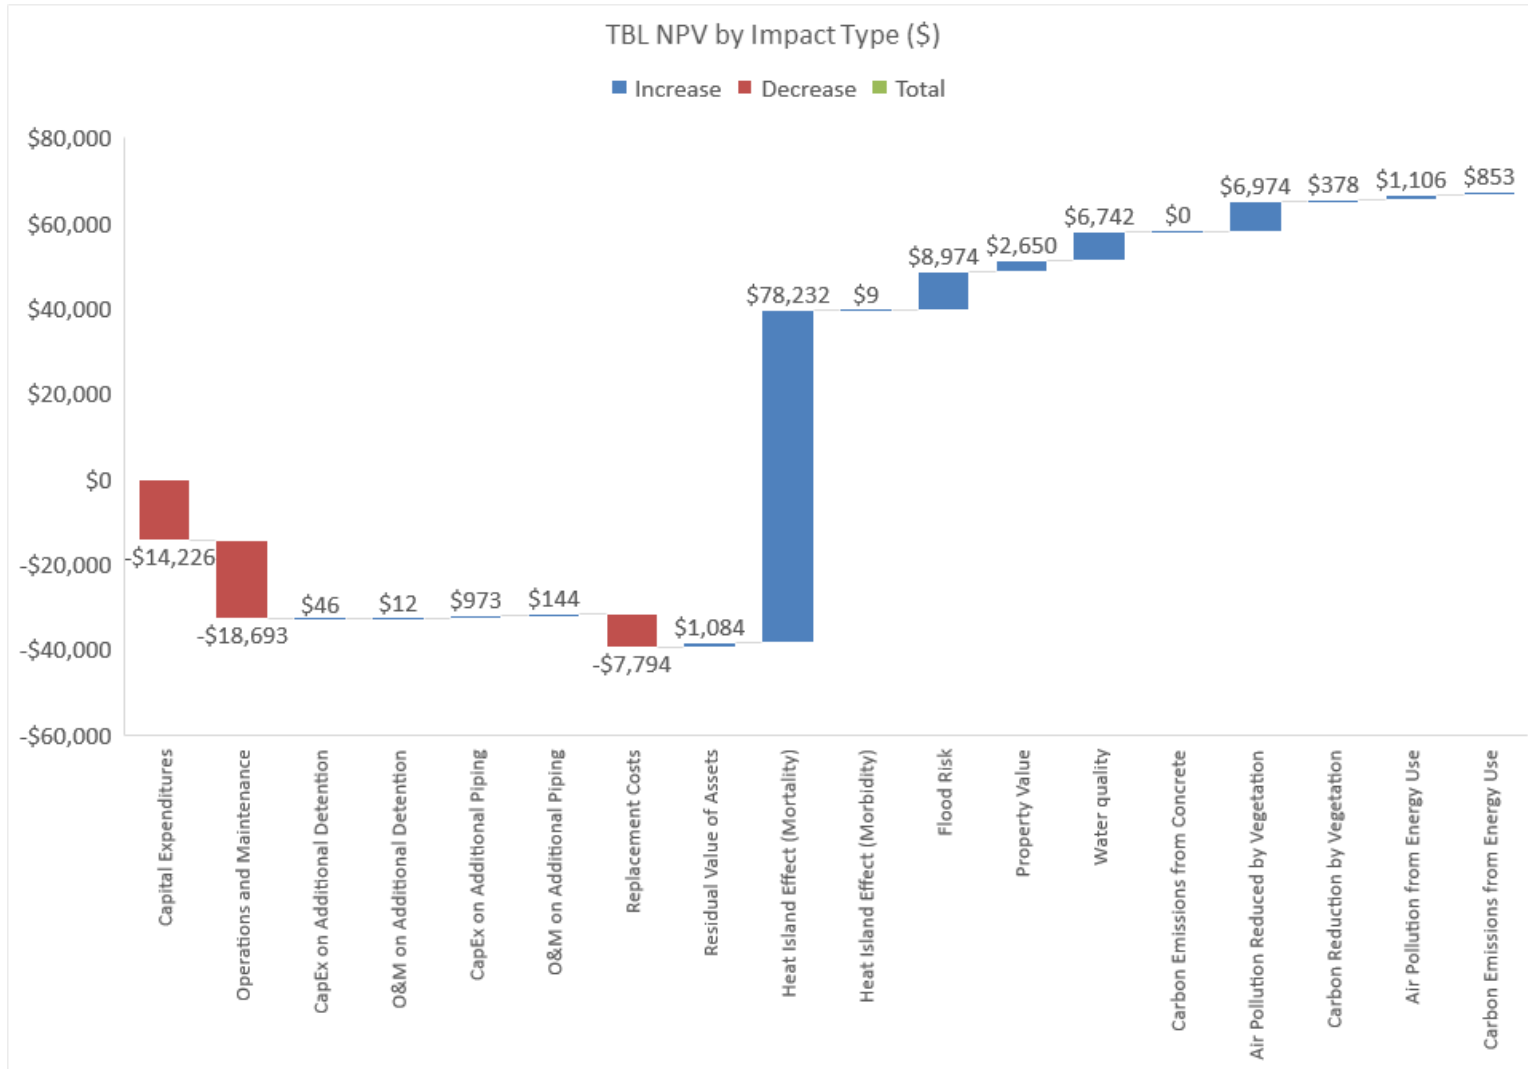
Figure 32: Breakdown of TBL NPV by Impact Type for Glendale

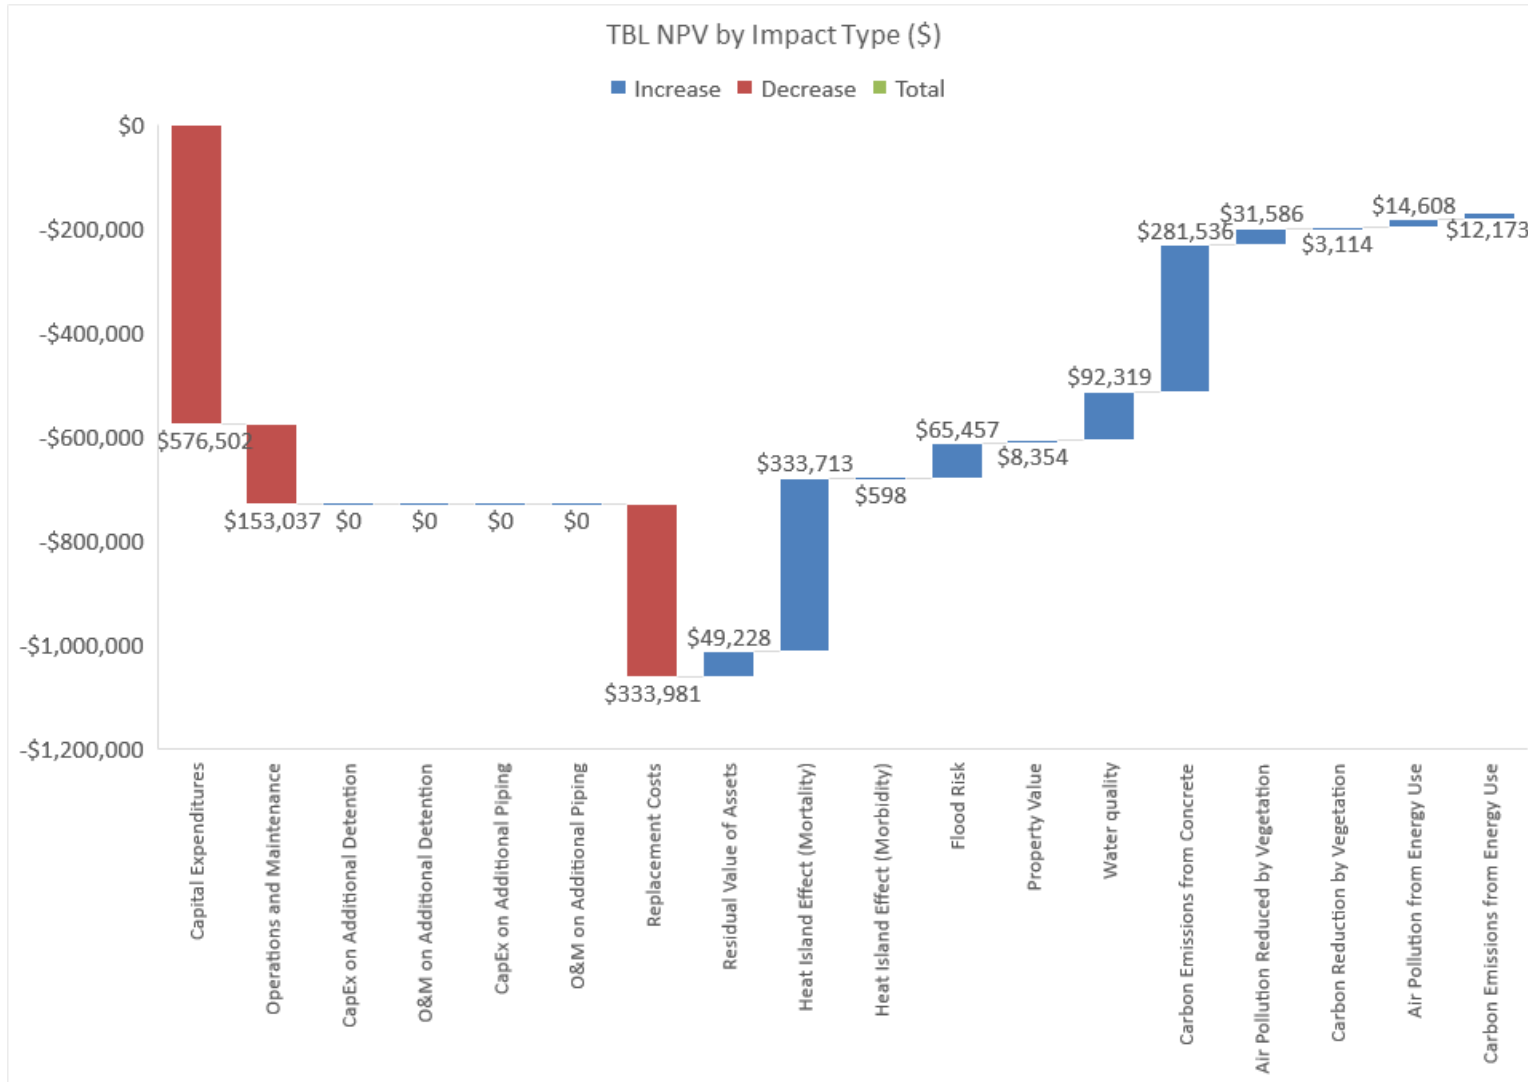
Figure 33: Breakdown of TBL NPV by Impact Type for Central/Civic/Taylor
