**Avenida Río Salado/  
Broadway Road**  
www.avenidariosalado.com

## Historic Structures and Districts Report

# **AVENIDA RIO SALADO: An Eligibility Evaluation of Historic Structures and Districts**

Ryden Architects Project No. 0803  
**March 2010**

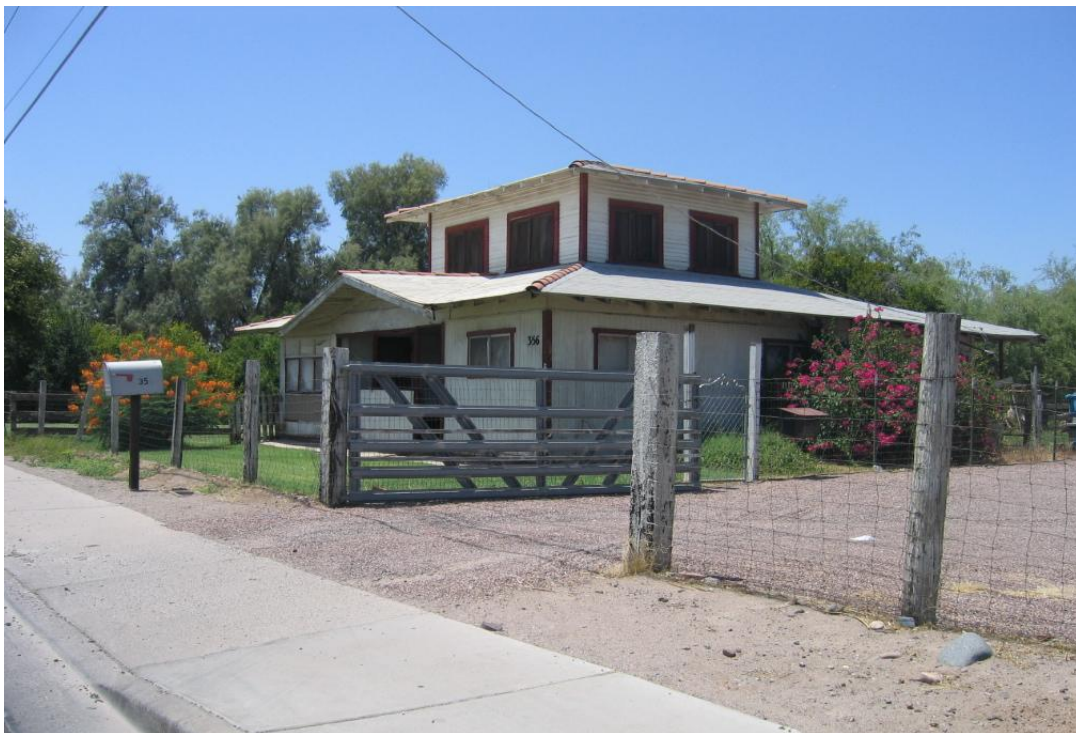
The two farmhouses within the APE are recommended as eligible for the NRHP under the context of rural architecture of Phoenix, 1911 to 1967. In June 1991 the Woodward Architectural Group prepared a thematic survey report for the City of Phoenix Historic Preservation Office that evaluated the surviving “Rural and Estate Architecture of Phoenix.” This survey identified only 50 agricultural properties built between 1911 and 1942 within the Phoenix city limits north of Baseline Road. This survey recommended that the **Vernacular Farm Cottage** (356 W. Broadway Road, Parcel 113-05-044) be considered not eligible for listing on the National Register due to loss of integrity from alterations and additions (Figure 16).

**Figure 16. Vernacular Farm Cottage at 356 W. Broadway Road.**

Seventeen years later, we have re-evaluated this farm cottage and recommend that it be considered individually eligible for listing. We believe that the loss of so many rural farmhouses to recent urbanization has made this dwelling *a rare surviving example of a once common type*. Furthermore, we see the homeowner alterations and additions to the building to be typical and indicative of the changes typically made to farm buildings of all kinds. Based on the materials and methods used for the modifications to this modest home, the changes appear to have been done during its historic period (prior to 1958) and thus appear to have attained a significance of their own. The enclosure of the original recessed front porch with screens and wood windows was a common method of providing more living space beneath the existing original main roof. Wood-framed additions to the rear of the house continue the original construction method of weatherboard siding. These additions extend the plane and slope of the original roof. For these reasons we believe that the 1991 evaluation be reversed; we recommend that the building, its outbuilding, and its setting today are indeed eligible for listing on the NRHP.

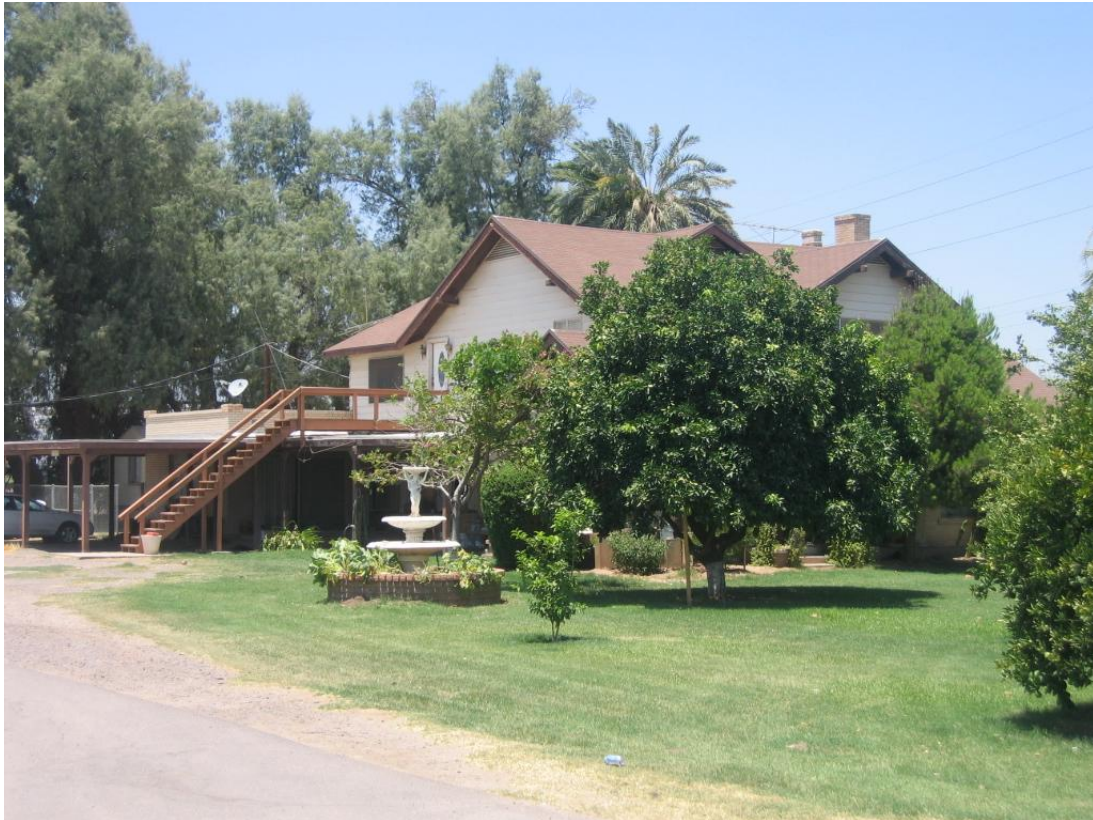
By way of contrast, we also discovered a large, high-style **Bungalow Farmhouse** (4812 S. 43<sup>rd</sup> Avenue, Parcel 104-62-003) from about 1926 that retains a remarkable degree of integrity for an agriculture-related building commonly subject to extensive modification (Figure 17). The 1991 Woodward report also recommended this farmhouse ineligible for the NRHP. The property also has retained its lush, flood-irrigated setting of lawn, shrubs, and large shade trees. However, it no longer has a barnyard or fields, which have been replaced by a modern-era pre-fabricated metal building containing a furniture manufacturer and by adjacent sand and rock mining facilities.

**Figure 17. Bungalow Farmhouse at 4812 S. 43<sup>rd</sup> Avenue.**

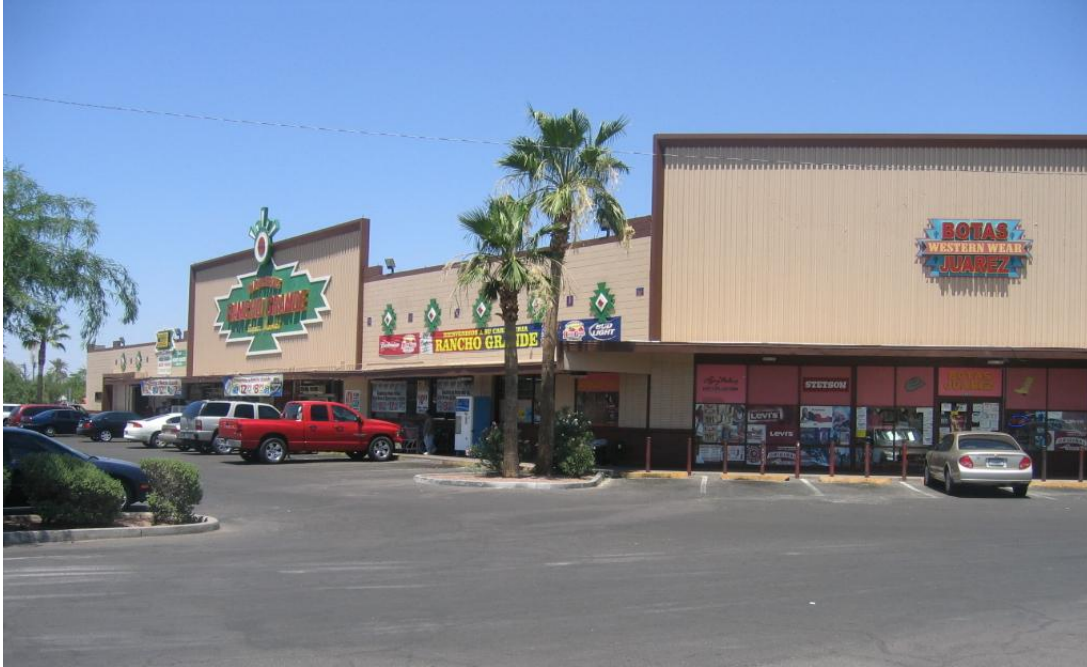
Within the APE of this project, the neighborhood shopping center (4221 S. Central Avenue, Parcel 113-13-085F.) standing at the northeast corner of Central Avenue and Broadway Road is an example of this mid-century commercial property type (Figure 18). Although the County Assessor records show the construction date of 1956, the city directories record the first occupancy of the property in 1958 by Thomas Jewelers, Phoenix Auto Supply, Westinghouse Laundromat, United Loan Co. of Maricopa, and the Broadway Barber & Beauty Shop, as well as others. The first listing of an anchor store is the Ranch Market Grocery beginning in 1964. That year also saw the presence of State Securities, Inc. and the KCAC Broadcasting Co. In 1966 Budget Finance Plan took occupancy of a suite. In 1973 the grocery store was listed as the Ranch Market; the United Academy of Beauty moved into the center that year. In 1986 the market's address was marked as being vacant. The entire shopping center was remodeled from its original Modernist character to a Spanish Eclectic image when the supermarket reopened during post-historic period under the current name Mercado Rancho Grande. This recent modification has caused a loss of original integrity of design and materials that precludes its eligibility for listing on the NRHP.

**Figure 18. The A.J. Bayless Supermarket at 4221 S. Central Avenue was the anchor store of a Modernism-inspired neighborhood strip center.**

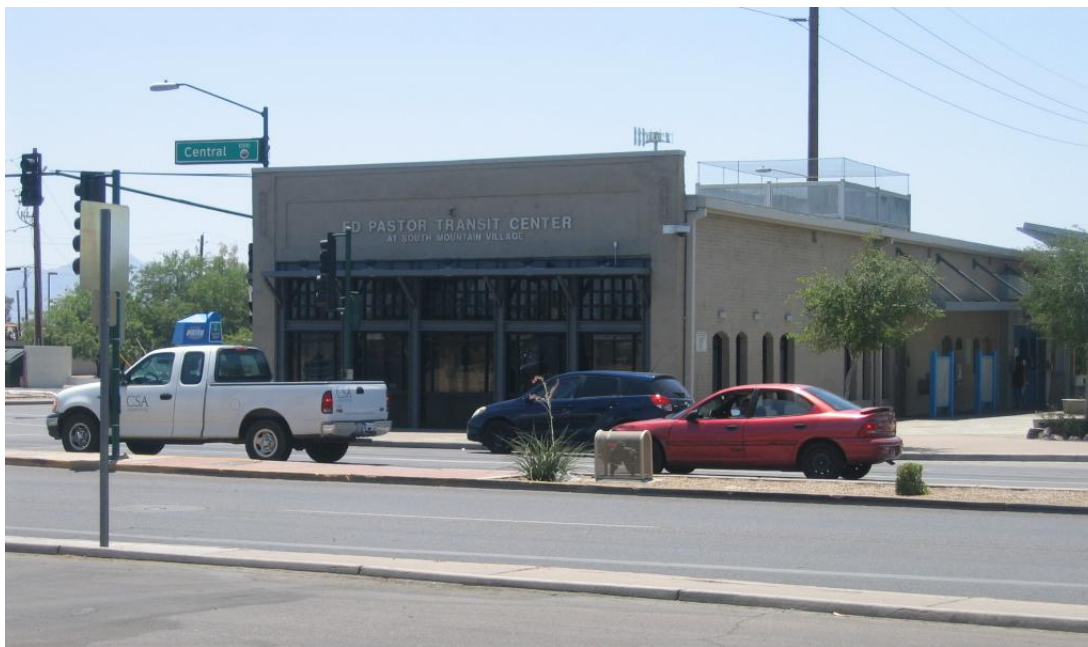
Three commercial structures in the APE are recommended eligible for the NRHP under the context of commercial architecture of Phoenix, 1911 to 1967. The 1936 **Pay-N-Takit Market** (10 W. Broadway Road, Parcel 113-07-123) is one of only six known remaining examples of these pre-WWII grocery stores in Phoenix. During the 1920s and 1930s the Pay-N-Takit retail grocery business constructed numerous franchised markets throughout Phoenix to serve residential neighborhoods. Each of these markets was constructed as a one-part commercial block.

The Central and Broadway market was built on the corner and had a parking lot on the north side. These siting strategies cleverly integrated the traditional one-part commercial block building form with the modern paradigm of motorist shoppers. These stores, in keeping with the corporate image of Pay-N-Takit, were of different designs rendered in the Spanish Eclectic style so popular in Phoenix in the early 20<sup>th</sup> century (Ryden and Pry 2002:31). The Central and Broadway market has been rehabilitated by the City of Phoenix Transportation Department for use as the Ed Pastor Transit Center, a regional bus station for Valley Metro (Figure 19). Although it has been modified for its new use, it retains sufficient integrity of design, materials, workmanship, and feeling for it to convey its architectural significance as an excellent example of a one-part commercial block grocery store in pre-WWII Phoenix.

**Figure 19. The Pay-N-Takit Market at 10 W. Broadway Road.**

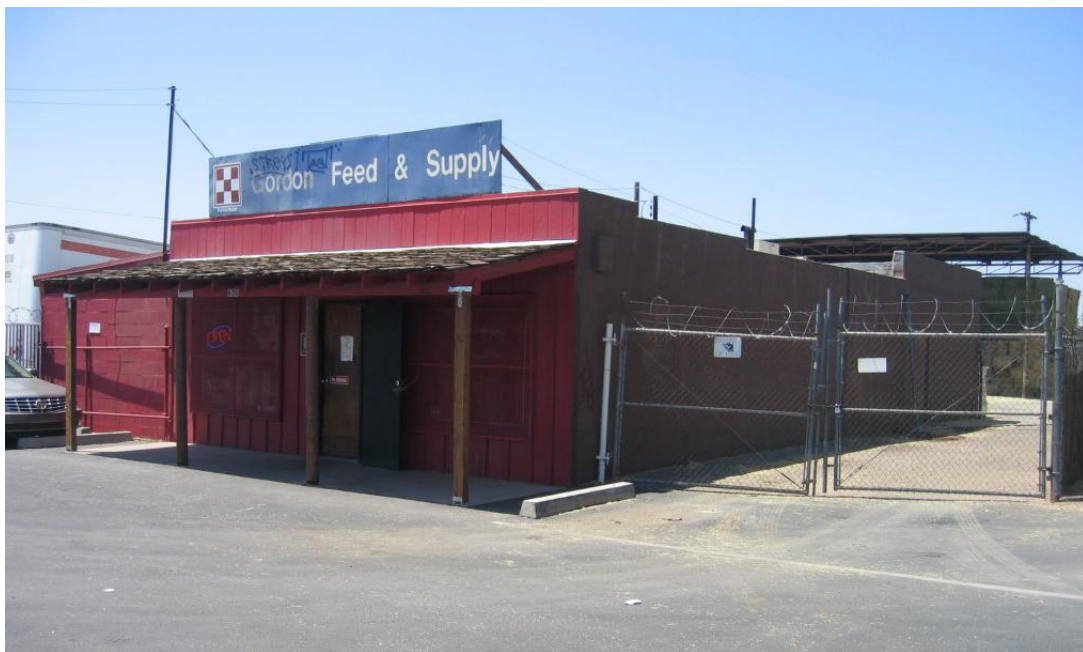
The Gordon Feed & Supply Building, originally the Port Stop Boats and Motors from 1960 to 1970, was designed in a style that evokes the popular imagery of the Old West. This mid-century retail store is an architectural interpretation of its frontier predecessors. Ranch Style commercial buildings combine a palette of rustic materials with the massing of the Boomtown Style associated with frontier towns. The Ranch Style is characterized by materials including board-and-batten siding, windows of fixed wooden frames or steel casements, wood shingles or shakes, squared wood porch posts, clay bricks or concrete blocks (natural or painted), and concrete walkways. The Boomtown Style one-part commercial block has a rectangular plan with either a front gable roof or a flat roof with parapets. Its front façade is the most important characteristic of this style. The storefront façade consists of a central door flanked by separate windows. The width of the façade is sheltered by a shed porch, above which rises a high parapet roof concealing the roof and providing a surface for the business sign. The historic significance of this building is enhanced by the steel hay barn in the back yard that may be a remnant of previous residential development in the Broadway Gardens Subdivision established in 1945. This subdivision was created from part of the much larger 1870s homestead of Michael Wormser, a real estate investor who came to acquire huge farmland areas south of the Salt River.

**Figure 20. Gordon Feed & Supply at 600 W. Broadway Road.**

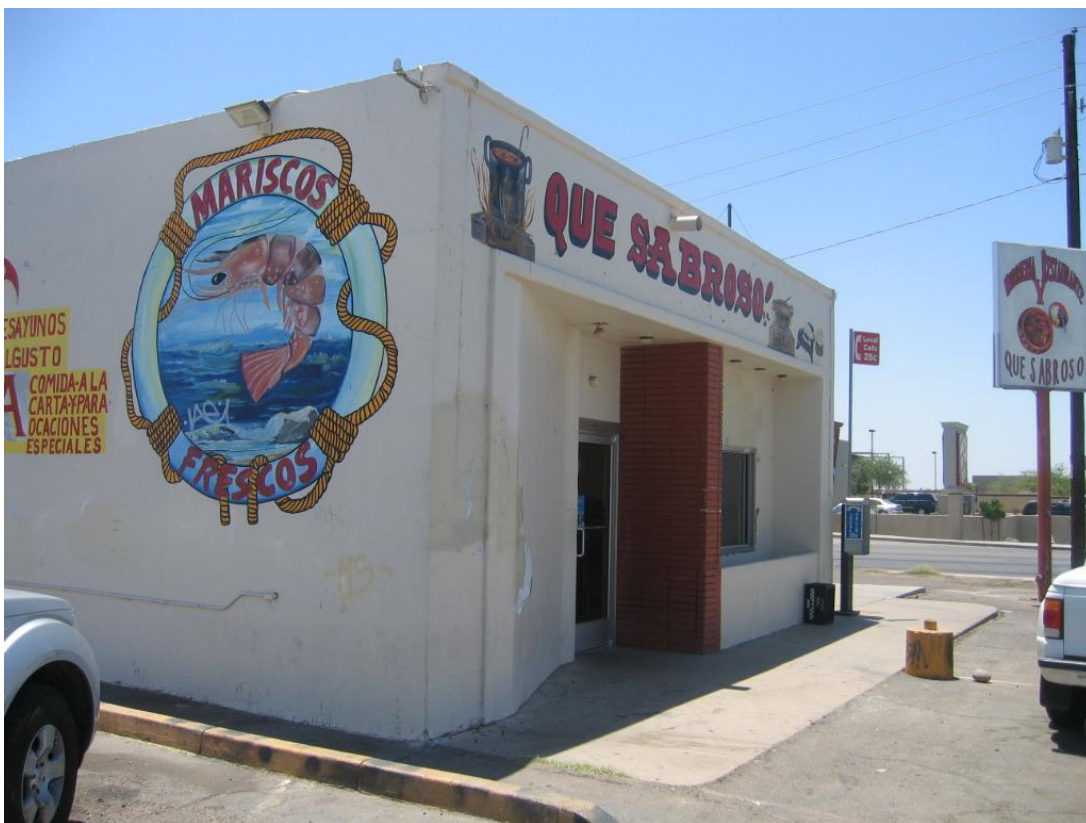
**Restaurant Que! Sabroso** (1855 W. Broadway Road, Parcel 105-64-001) is a modest, but rare, example of the Modernist influence on mid-century storefront design in South Phoenix (Figure 21). Very few such building facades have survived along Broadway Road. The simple box-like massing of the stucco-sheathed building is undistinguished except for the design of the front façade that is an artistic composition of rectangular flat planes and voids. The framed façade has a 3-foot-deep recessed storefront equally split by a stack bond Roman brick wing wall that separates the angled front wall and aluminum and glass door from the raised built-in planter surmounted by an aluminum-framed picture window. The recessed down lights within the soffit wash down the storefront wall. The north-facing façade has no projecting canopy. The current business sign is painted on the parapet wall above the recessed storefront. Toward the back half of the long sidewalls are in-filled high windows. Two low windows near the front corner of the west wall have been secured with ornamental iron grilles. And a double door has been cut into the center of the west wall.

**Figure 21. Restaurant Que! Sabroso at 1855 W. Broadway Rd.**

**Restaurant Que! Sabroso** (1855 W. Broadway Road, Parcel 105-64-001) built in 1950 is a modest, but rare, example of the Modernist influence on mid-century storefront design in south Phoenix. Only its front façade reflects the Modernist character of commercial architecture; the other three sides have several in-filled windows or modified doors. The front façade alone is sufficient to convey its architectural significance. City directories indicate that the restaurant was known as "Jack and Ann's" in 1953 and as "Manzanita Bar and Grill" in 1956. The building is recommended eligible at a local level of significance under Criterion C for its association with post-World War II commercial architecture in Phoenix.

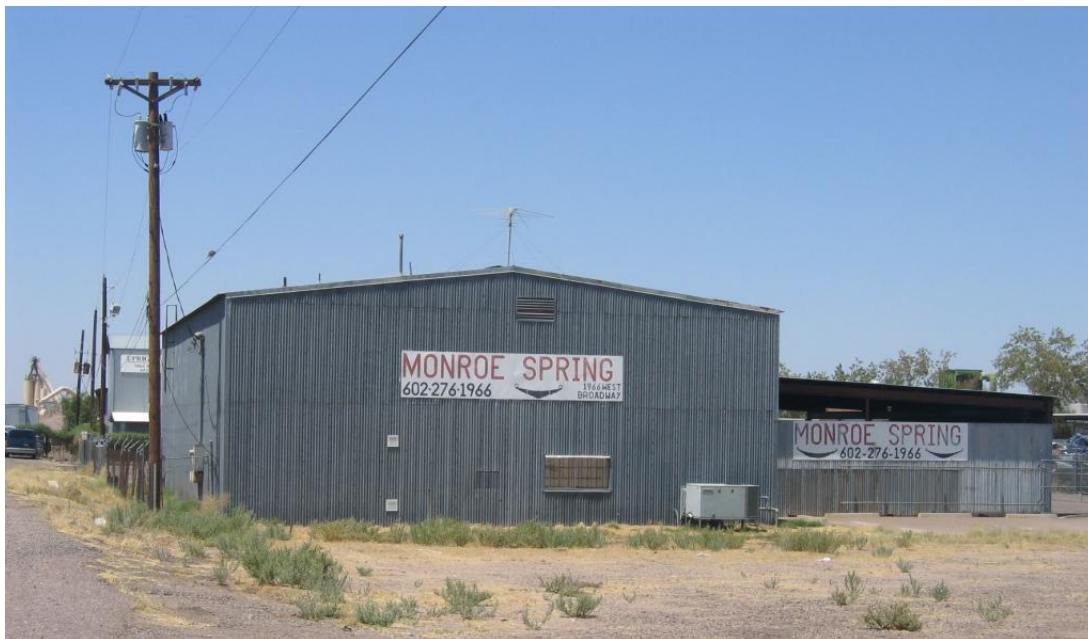
The 1966 **Monroe Auto Spring and Suspension Service Building** (1966 East Broadway Road, Parcel 105-52-004H) is a rare surviving example of once common post-World War II prefabricated steel industrial-type structures (Figure 22). The Monroe Spring Building was used as a commercial repair shop which serviced automobiles, farm vehicles, and heavy construction equipment. It may have been associated with the nationally known Monroe Company which produced and installed shock absorbers and other automotive parts. Its open-ended rear (north) façade allowed large vehicles to be brought into a shaded workspace. Having sustained little alteration, it retains a high level of original integrity in design, materials, and workmanship. The building is recommended eligible for listing on the NRHP at a local level of

significance under Criterion C for its association with post-World War II industrial building construction methods.

**Figure 22. Monroe Spring building at 1966 W. Broadway Road.**

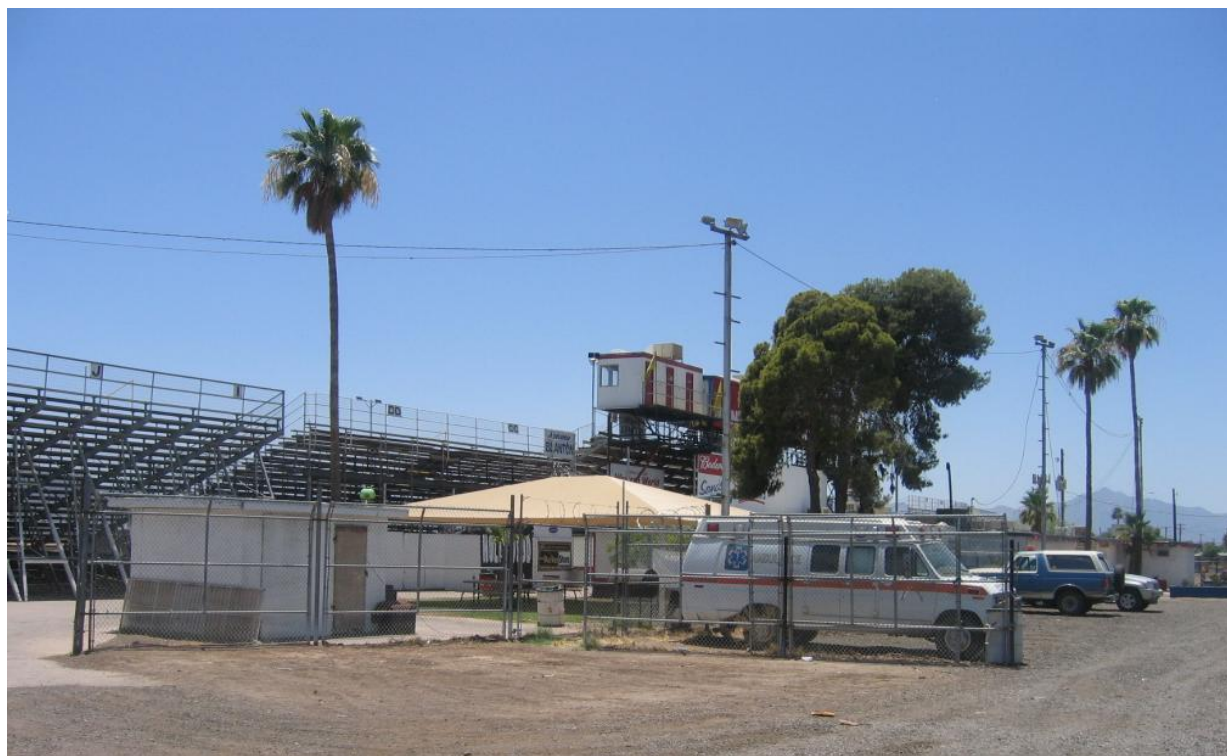
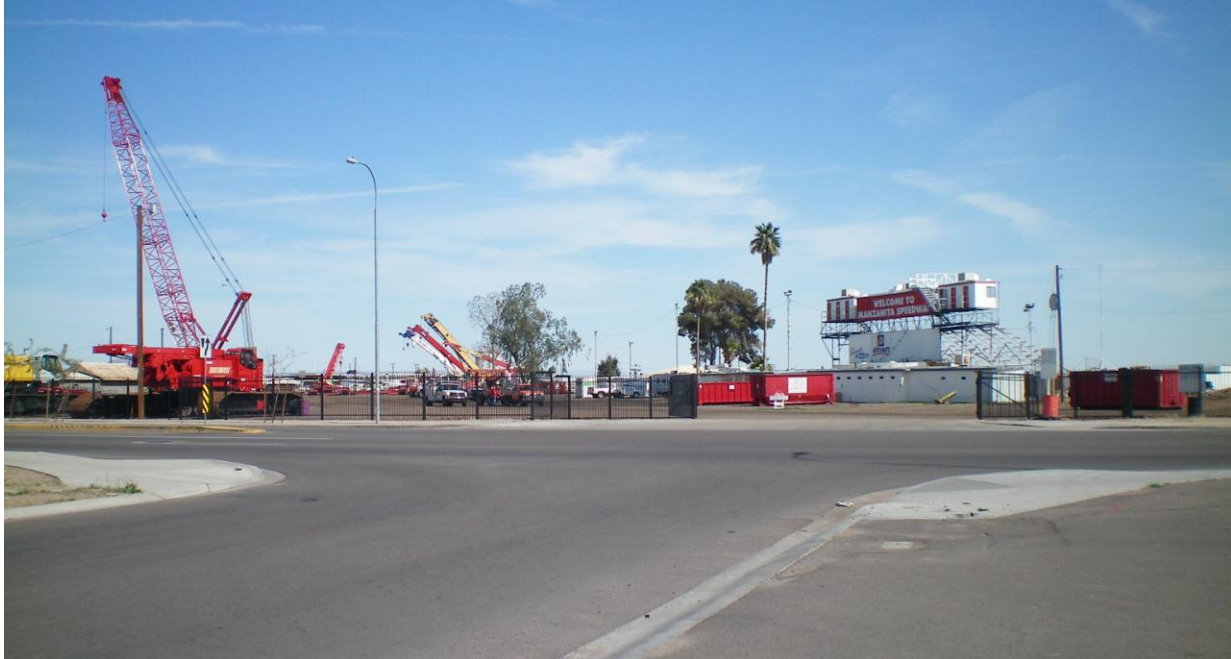
Manzanita Speedway had *previously* been recommended as being eligible for listing on the NRHP at a local level of significance under Criterion A for its association with automobile racing entertainment in Phoenix from 1951 to 1960. However, with the loss of its bleachers, the Speedway no longer retains sufficient integrity of design and materials to convey its significance as an important raceway entertainment venue. Thus, it cannot be considered eligible for NRHP listing.

**Figure 23. 2009 photograph of Manzanita Speedway at 3417 W. Broadway Road before the sale.**

**Figure 24. 2010 photograph of Manzanita Speedway after the sale.**

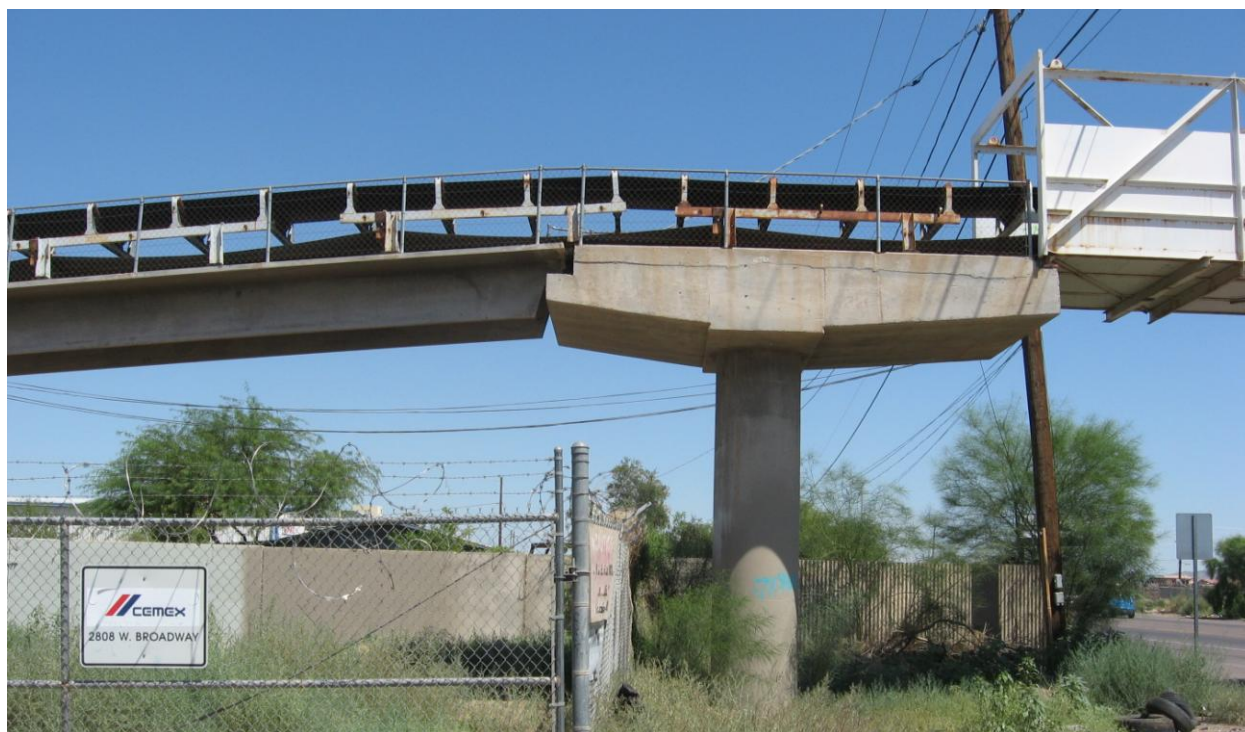
Occasionally there are more permanent structures associated with sand and gravel mining. The **Cemex Gravel Conveyor Structure**, a pre-cast concrete spanning over Broadway Road approximately 500 ft west of 27<sup>th</sup> Avenue, was constructed between 1959 and 1964 (Figure 25). It is recommended eligible for its association with the sand and rock mining industry in the Salt River Valley. Because of the transitory nature of riverbed mining, very few remnants of this industry remain behind as reminders of this important local industry.

**Figure 25. Elevated gravel conveyor over Broadway Road west of 27<sup>th</sup> Avenue.**

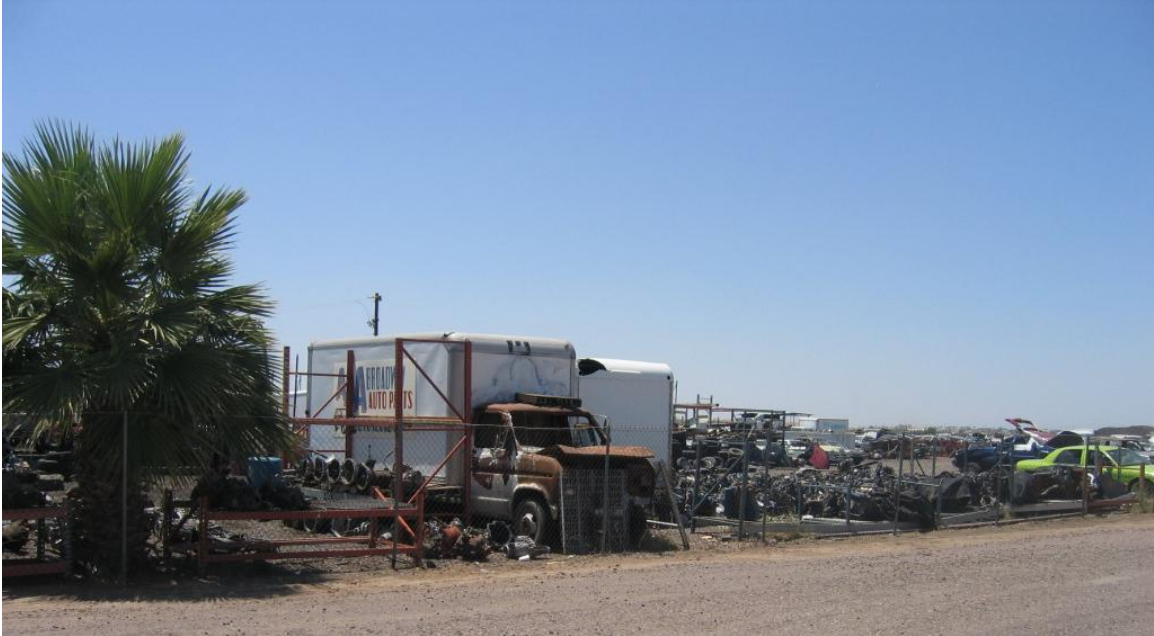
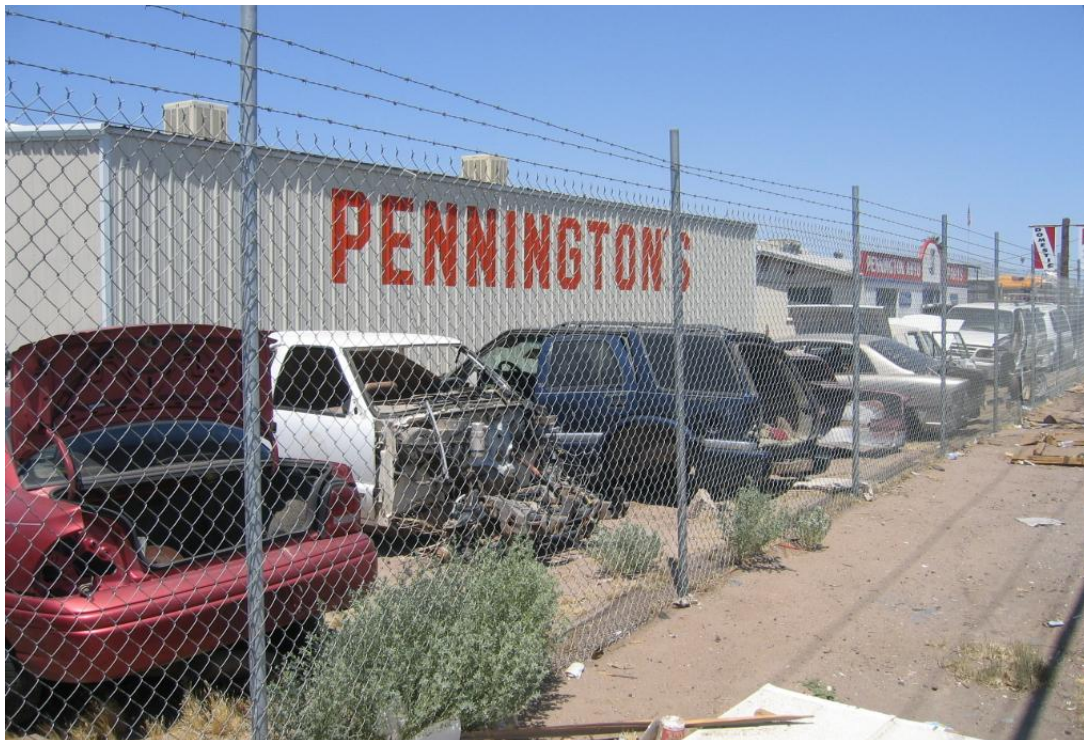
The predominant land use in the APE is the auto salvage yard (Figures 26–28). These salvage yards are associated with the context of junkyards in the Salt River Valley, 1946 to the present. Although not conclusively proven, it is possible that the presence of Manzanita Speedway encouraged the industries related to automobiles to be established nearby. Its presence may also have been a catalyst for similar industrial and commercial development toward the west along Broadway Road that had not existed prior to the speedway’s founding (Bethke 2007).

**Figure 26. A typical auto salvage yard along Broadway Road as seen from a side street.**

**Figure 27. Pennington's Auto Salvage was the first junkyard on Broadway Road to appear shortly after World War II.**

**Figure 28. 2009 Maricopa County aerial photograph of junkyards near 23<sup>rd</sup> Avenue and Broadway Road.**

In evaluating these Broadway Road junkyards and auto parts salvage yards from a historical perspective one finds that they will not be NRHP-eligible properties because of lack of significance. Archaeologically, they would not likely have the potential to disclose information, for the artifacts of interest both above and below the surface are of modern vintage and not likely to yield significant information about the recent past. If the junkyard was to go out of business and the inventory was to be cleared away to another location, there would be nothing left to examine as a historic artifact. Architecturally, the only permanent character-defining features of a junkyard are the sign, the perimeter fence, and the office building, which might even be a mobile home. However, it must be noted that several of the buildings along Broadway Road appear to be old agricultural buildings (Figures 29–30). Two adjacent junkyards have office buildings that were adapted from identical Bungalow Style cottages (38 and 42 E. Broadway Road, 113-33-094A and 113-13-092A) built in 1926. These two cottages are now severely deteriorated. Based upon historic maps and aerial photographs, these acreage properties appear to have been subsistence "ranchettes" that were subdivided from earlier large homesteads or farms. These narrow, deep properties were developed with a small house near the front and agricultural activities in the rear. Although the flood-irrigated properties were large enough for truck farming or limited livestock, they were not suited for cotton, hay, or grain. Small-scaled dairy farming may have been possible through a cooperative milk processing association. When families could no longer subsist by farming such small parcels, the properties appear to have been sold and converted to industrial or commercial uses.

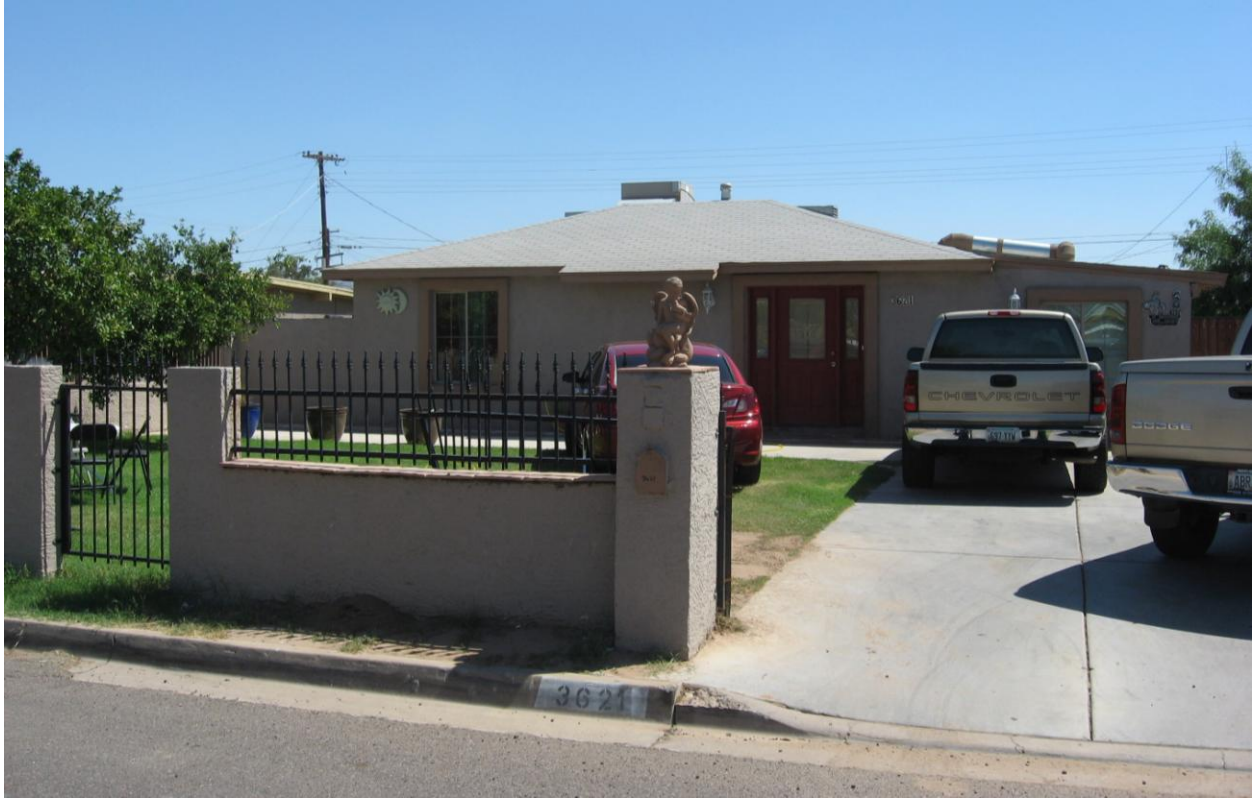
The limited variety of floor plans, roof shapes, and windows implies that the concrete-block houses of the subdivision may have been constructed by several different contractors. Particularly notable here is the contemporaneous occurrence of steel casement and aluminum sliding sashes original elements of the houses. Few of the houses were equipped originally with carports (Figure 32), but most now have had carport or garage additions built on the side elevation. Subsequently, many of the carports were in-filled to expand the living area of the houses. These additions and in-fills are of varying levels of quality in form, detailing, and materials. In many cases where a side carport was in-filled, the homeowner would build another carport on the front façade or erect a free-standing temporary steel and canvas shade structure that detracted from the original character and massing of house. Also, because virtually none of the houses originally was built with entry porches, the addition of complementary porches may be considered appropriate changes to the Ranch Style façades.

**Figure 31. Example of a house lacking integrity (Lot 189 on Figure 32).**

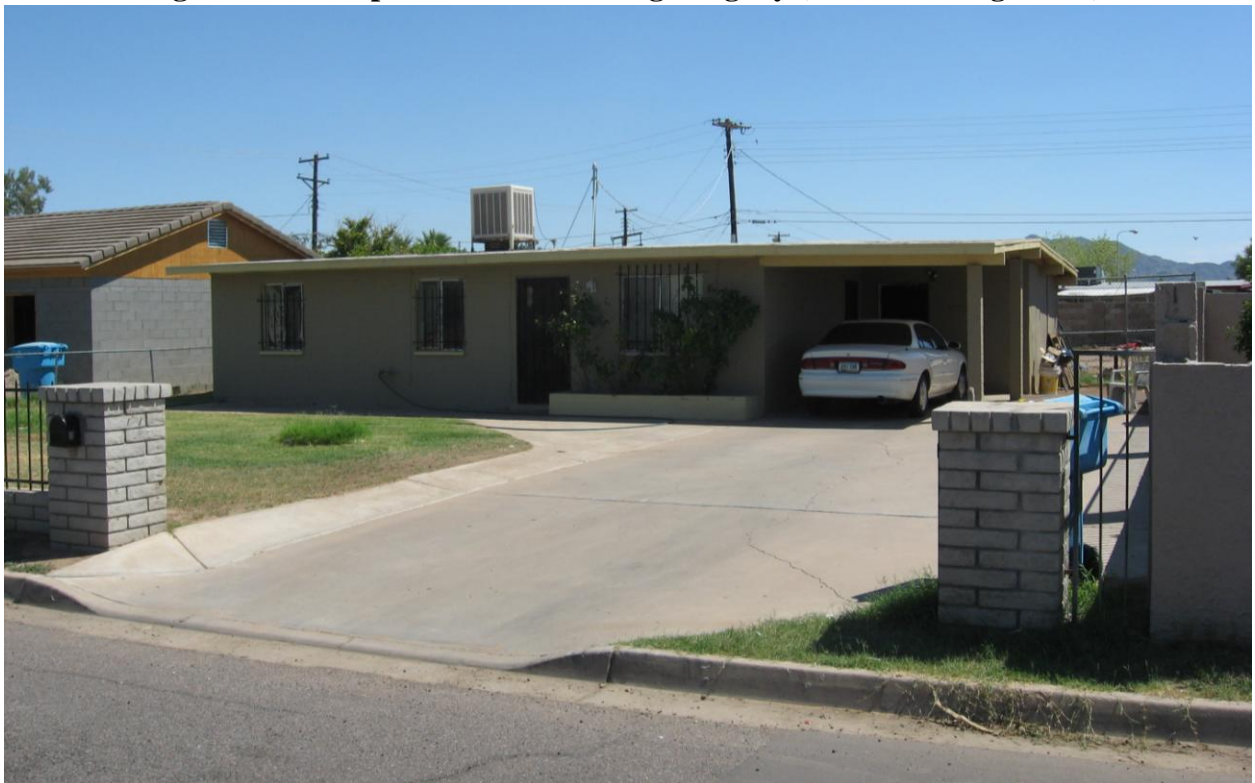
**Figure 32. Example of a house retaining integrity (Lot 188 on Figure 32).**

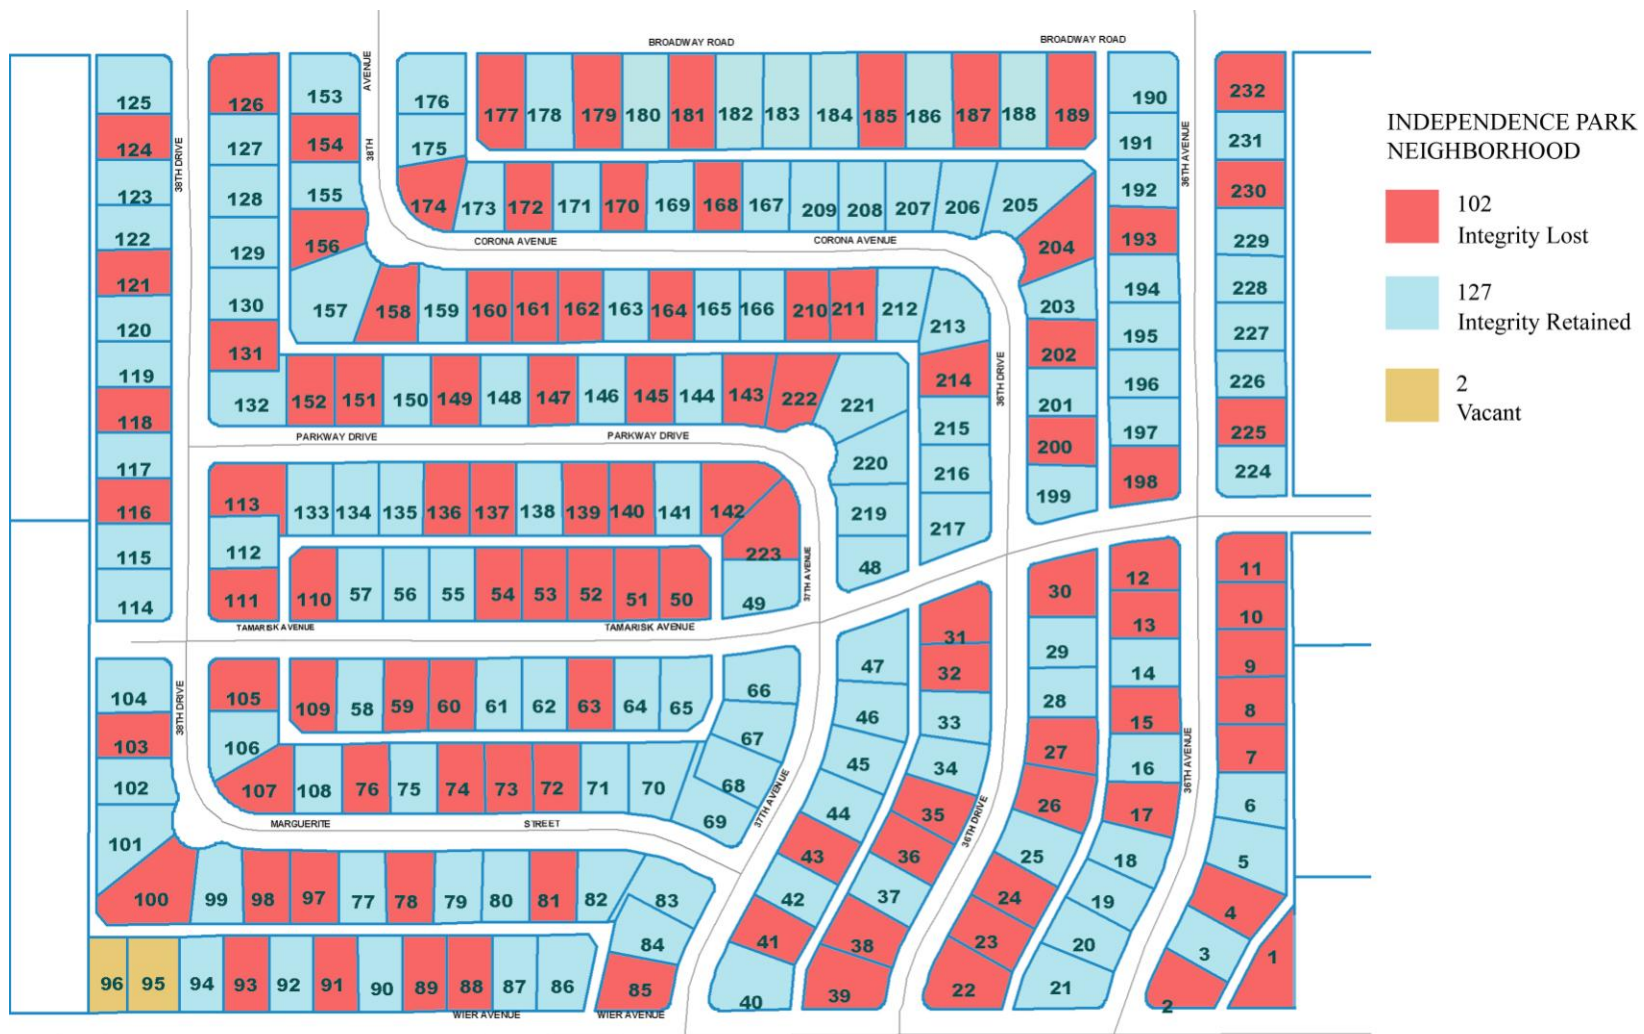
A visual integrity reconnaissance of the 1960-era **Independence Park Subdivision** at 38<sup>th</sup> Avenue and Broadway Road resulted in a preliminary evaluation as follows: 127 with sufficient integrity; 102 with loss of integrity; and 2 vacant lots (Figure 33) The subdivision is recommended not eligible for its association with the Hispanic American community of Phoenix or with the planning and development of mass-production housing in Phoenix. As homeowners remodeled these typical, modest tract houses, they imbued their homes and yards with the ethnic characteristics of the Hispanic American housescape. However, the majority of the additions and alterations to houses that possibly could have attained significance of their own appear to have been made after 1967, the end of the eligibility evaluation period.

**Figure 33. Distribution of parcels with houses retaining and lacking integrity in the Independence Park Subdivision.**  
(Numbers refer to lot numbers in the subdivision.)

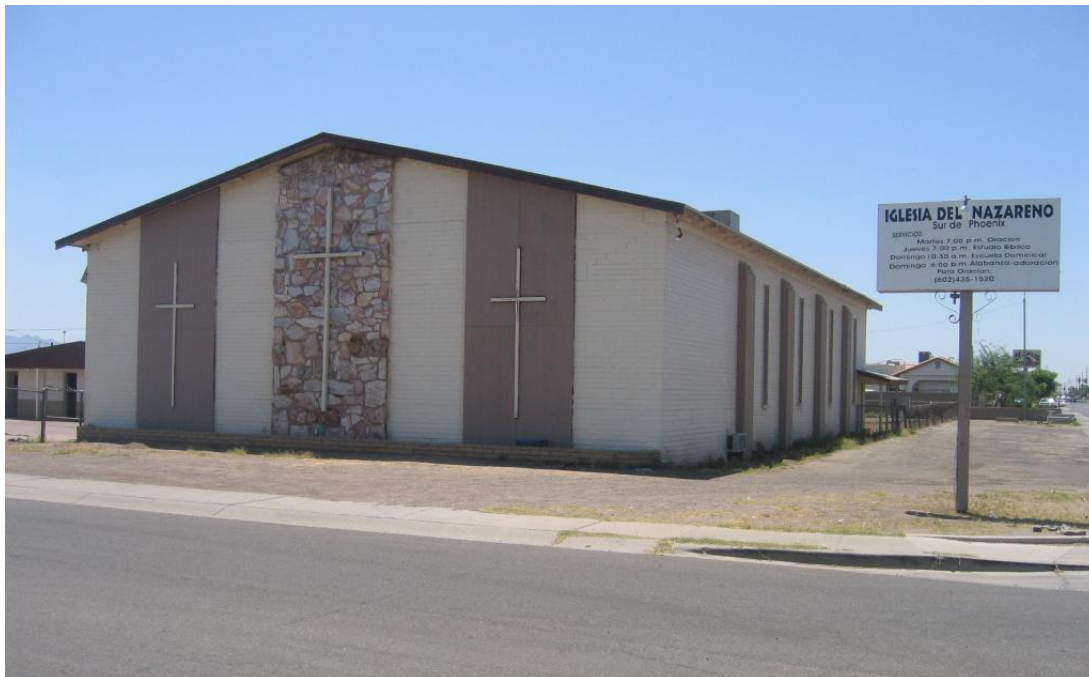
The architectural character of the 1950 South Phoenix Church of the Nazarene (525 East Broadway Road, Parcel 113-37-017A) is typical for a modest church of its period. The gable-roofed sanctuary, tower, and attached classroom wing are constructed of concrete block and can only be described as having Modernist influence rather than a specific high style. Although the building is associated with the context of religious architecture in post-World War II Phoenix, it does not have sufficient Modernist design significance under Criterion C to make it potentially eligible for listing on the NRHP. Further investigation may be needed to determine its eligibility under Criterion A for its association with community planning and development in Phoenix. (Figure 35.)

**Figure 35. South Phoenix Church of the Nazarene/Iglesia del Nazareno at 525 E. Broadway Road.**

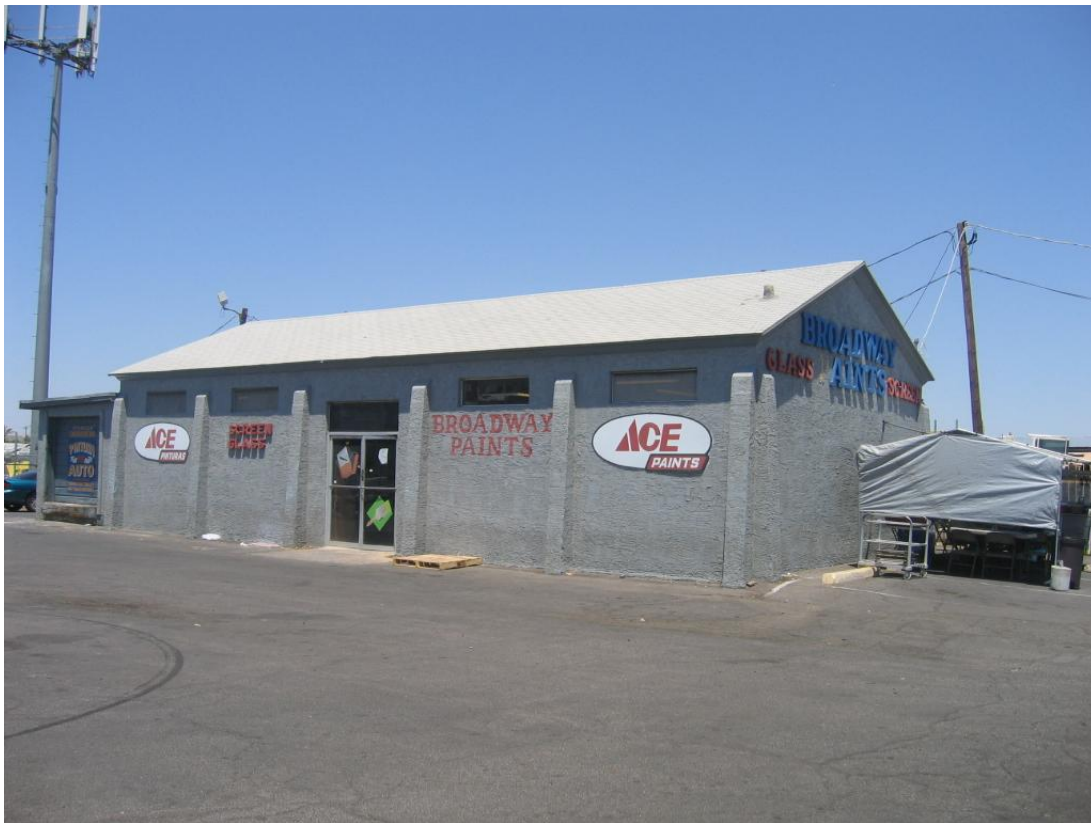
The church building was probably modified for use as a commercial building in 1987 for Broadway Paints & Décor. At that time the windows and doors were extensively modified by in-filling, replacement, and relocation. Only its rectangular, box-like massing, low-pitched front-gable roof, and series of buttresses along the long side walls still suggest its original use as a house of worship. A thick veneer of stucco conceals its exterior masonry walls. Although the building is associated with the context of religious architecture in Phoenix, it does not retain sufficient integrity of design and materials to be potentially eligible for listing at a local level of significance under Criterion C (Figure 36).

**Figure 36. Former Broadway Methodist Church building at 32 E. Broadway Road.**

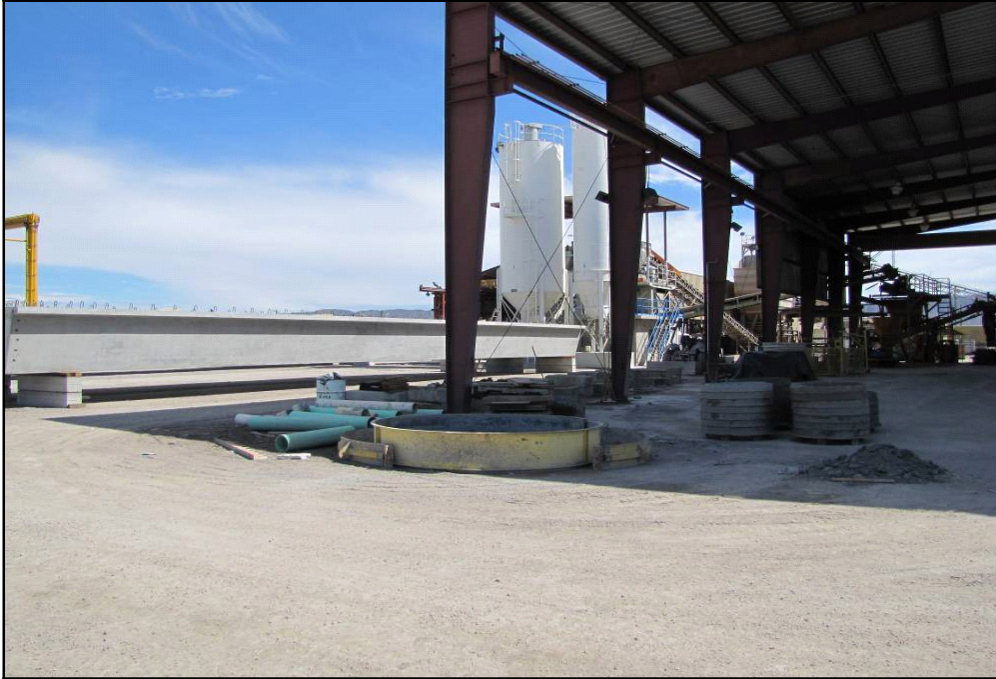
Smith Septic Tank/Smith Pre-Cast Co., batch plant.

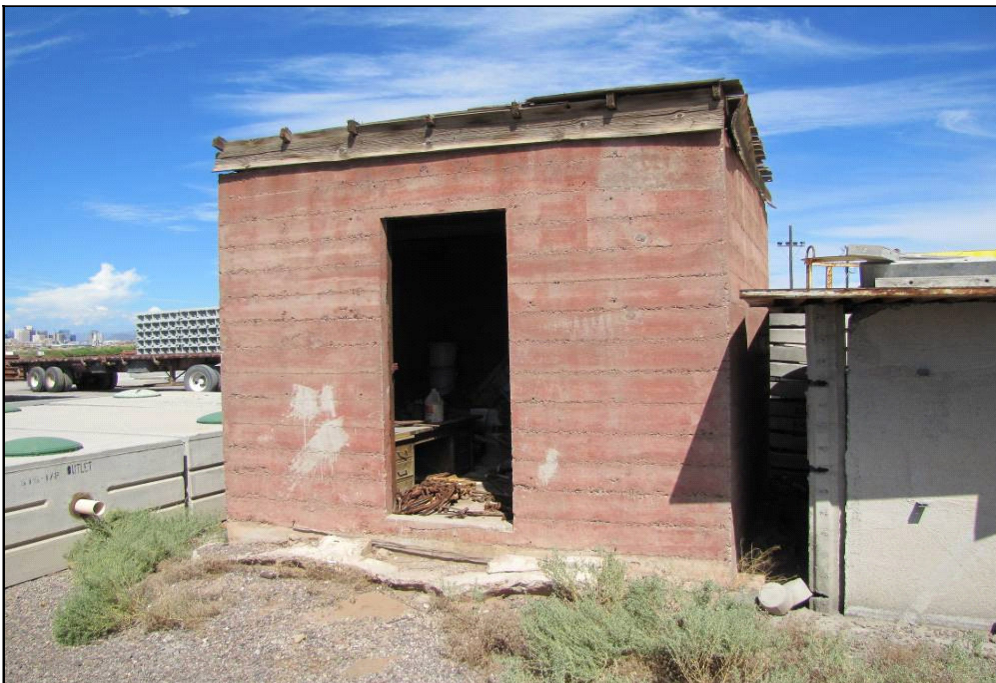
Smith Septic Tank/Smith Pre-Cast Co., dynamite shed.
