City of Phoenix Code Review to Promote Green Infrastructure – Case Study

1 Introduction

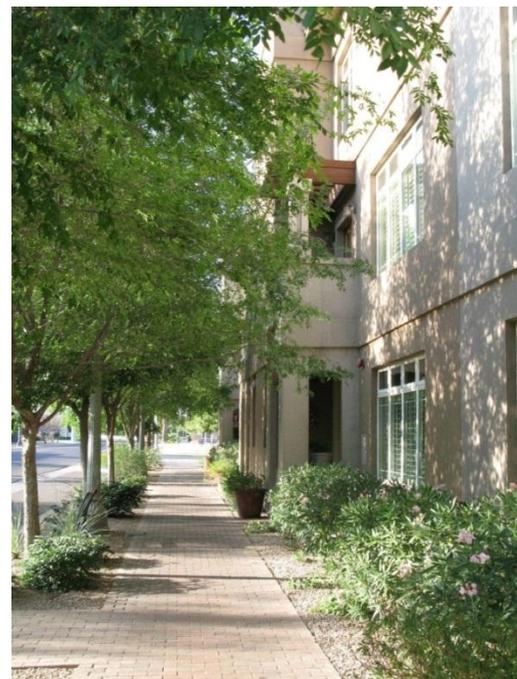
Figure 1. Trees Along 3rd Avenue and Roosevelt (courtesy City of Phoenix)

- Preserving trees (to provide water quality, heat island, and other triple-bottom-line benefits).
(**Figure 1**)

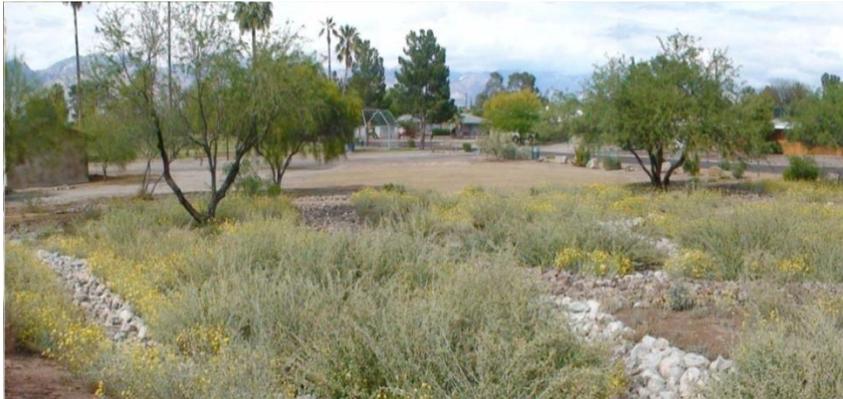
Figure 2. Retention in recreation area.

- Reducing the impervious area of streets and parking (to reduce water quality, flooding, and hydromodification impacts).
- Promoting green infrastructure practices that capture stormwater on site (to reduce water quality, flooding, and hydromodification impacts). (**Figures 2, 3, & 4**)
- Protecting washes.

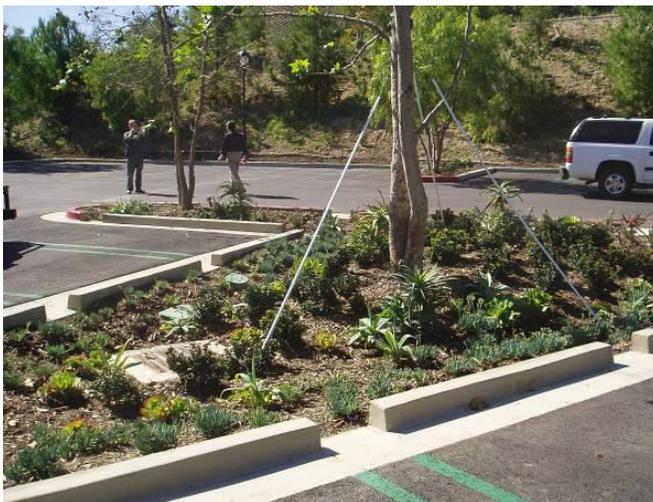
Figure 3. Parking lot runoff captured by bioretention in parking islands

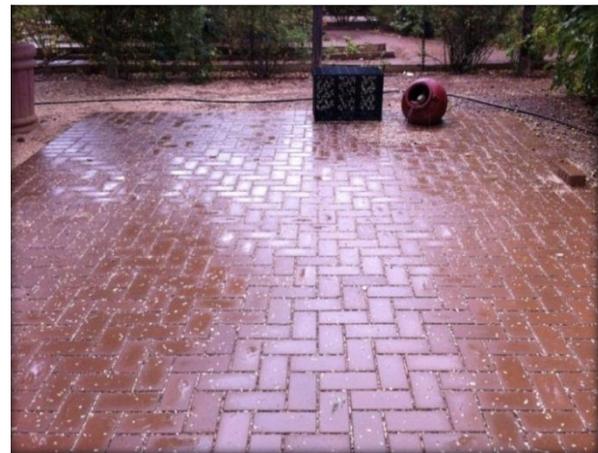
Figure 4. Permeable paver patio (courtesy Summer Waters, UA Cooperative Extension)

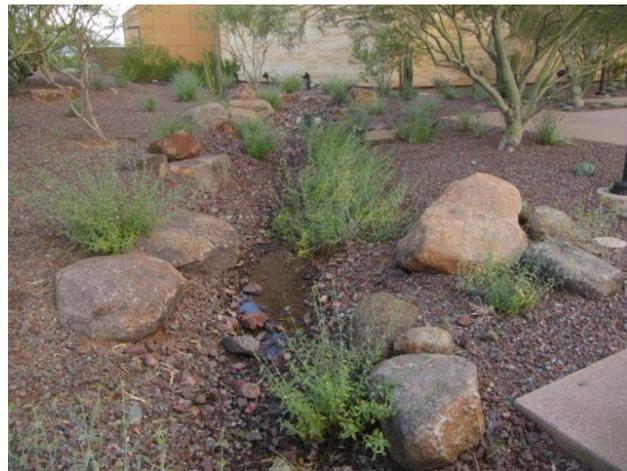
Figure 5. Water from roof directed to swale at Musical Instrument Museum (courtesy Summer Waters, UA Cooperative Extension)

- A stormwater policy that stresses the establishment of natural corridors for multi-use flood control, trails, recreation, and habitat, linking required open space to stormwater management. (Figure 5 and 6)

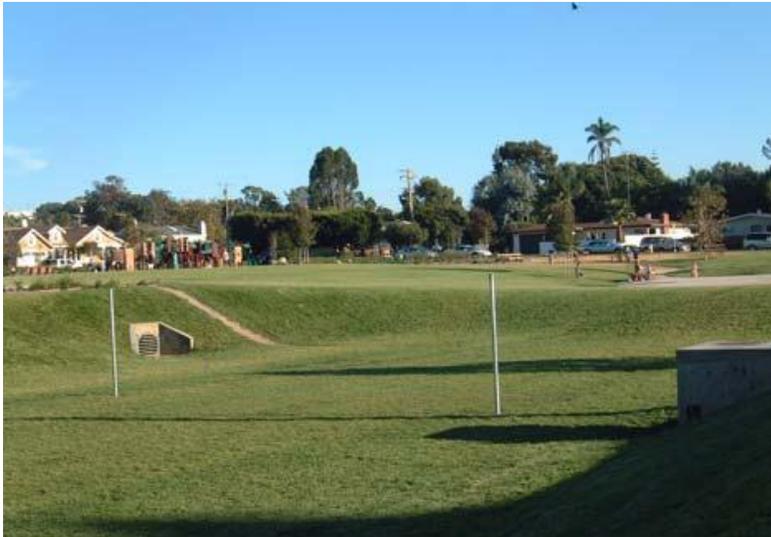
Figure 6. Retention/detention area also serving as volleyball court

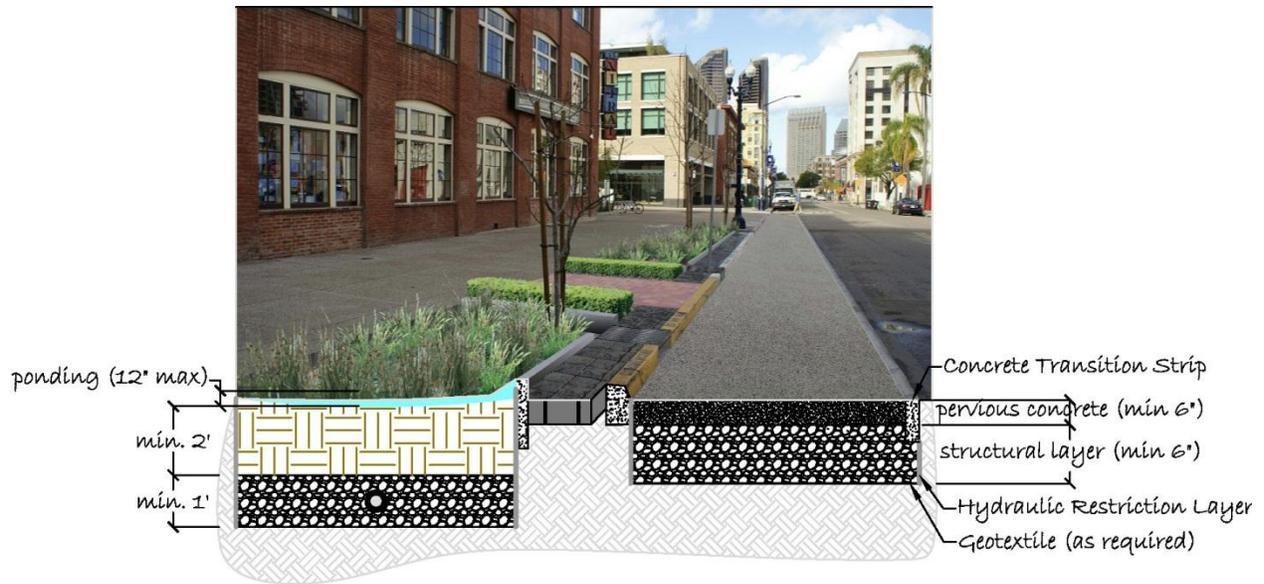
Figure 7. Example downtown streetscape standard for bioretention and pervious concrete

- Lack of weather-based or moisture-based irrigation controls.
- Lack of design templates for green infrastructure in the Street Landscape Standards and Street Planning and Design Guidelines. (**Figure 7**)

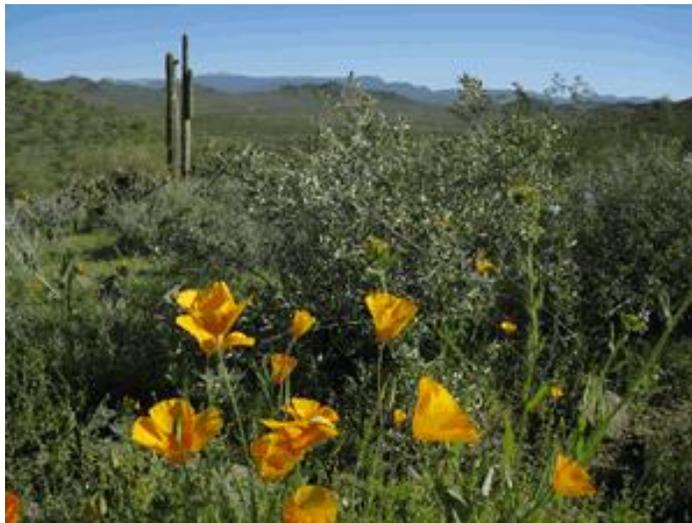
Figure 8. Example habitat conservation area for off-site mitigation (courtesy City of Phoenix)

- Lack of a Green Infrastructure Design Manual.
- Lack of an on-going inspections program for post-construction stormwater BMPs.
- Lack of offsite mitigation provisions for previously developed infill sites. Such offsite mitigation could help meet the City's habitat conservation goals (**Figure 8**), and help fund regional facilities to reduce existing impacts of stormwater runoff.
